NATIONAL TRANSPORTATION SAFETY BOARD
Vehicle Recorder Division
Washington, DC 20594

Onboard Image Recorder

Specialist's Factual Report
By Sean Payne

Location: Watkins, Colorado
Date: May 31, 2014
Aircraft: Cessna 150, N6275G
Operator: Private
NTSB Number: CEN14FA265

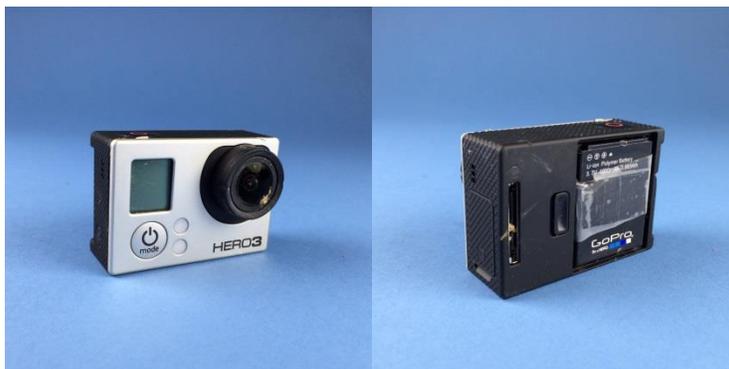
The GoPro camera arrived to the laboratory in an undamaged state. The lens and rear communications port was found to have trace amounts of debris. The rear battery door was missing, however, the unit was shipped with the battery in place. The GoPro was unable to power up using a charged battery. The SanDisk Ultra MicroSDXC 64GB memory card also arrived undamaged and was read out normally on a PC using a forensic write blocker. Figure 1 shows the condition of the GoPro Hero, figure 2 shows the condition of the SanDisk SDXC memory card.

Figure 1. The condition of the GoPro Camera.

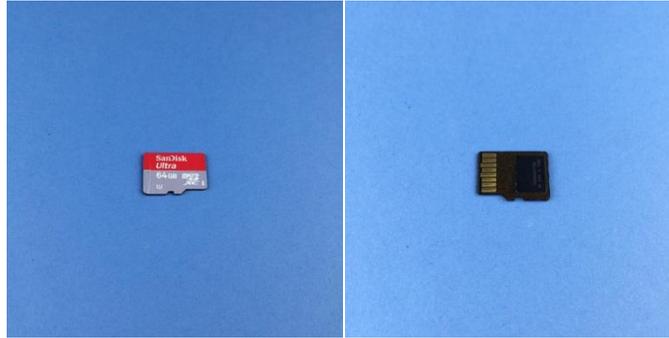
Figure 2. The condition of the micro SD card.
