NATIONAL TRANSPORTATION SAFETY BOARD

Survival Factors Group Chairman's Factual Report

CEN15MA290

Operator: Air Methods Corporation
Location: Frisco, Colorado
Date: July 3, 2015
Time: 1339 mountain daylight time
Aircraft: Airbus Helicopters AS350 B3e [N390LG]

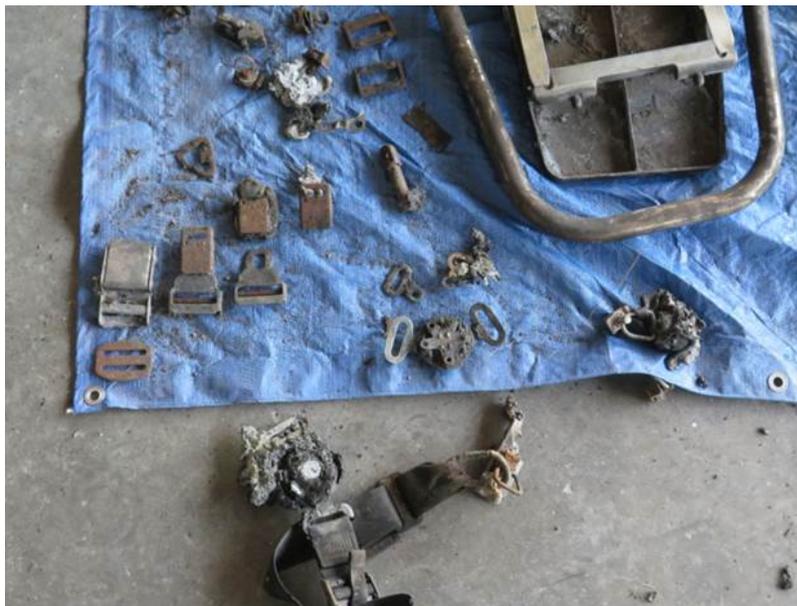
The majority of the main fuselage was consumed or severely damaged by the postcrash fire. A portion of the bottom structure was not consumed by the postcrash fire. Excluding the forward right door, the majority of the canopy and doors were consumed by the postcrash fire. The majority of the tailboom was also consumed by the postcrash fire. Two, four-point harness buckles were found loose among the burned wreckage, with the belt webbing mostly consumed by fire. The two lateral buckles of each were still intact to the buckle. Three other conventional type of restraint buckles were also found loose among the wreckage (Photograph 8).

Photograph 8- Photograph of restraint buckle found loose among the wreckage.

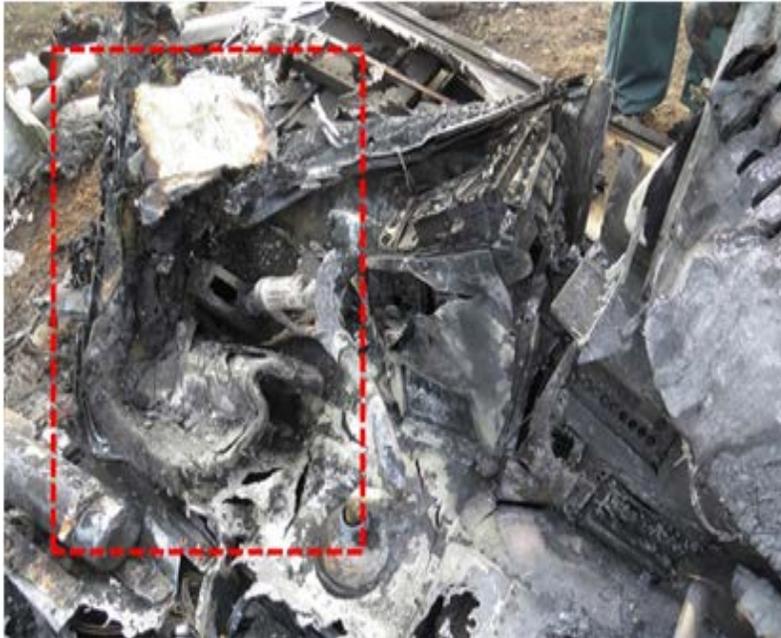
The pilot's seat was severely damaged by the postcrash fire, as shown in photograph 9. Damage to the floor and surrounding structure did not enable measurements or documentation of

the pilot's vertical seat position relative to the helicopter floor structure postcrash. (Photograph 9-13).

Photograph 9- The red box indicates the on-scene photograph of the pilot seat back and seatpan.

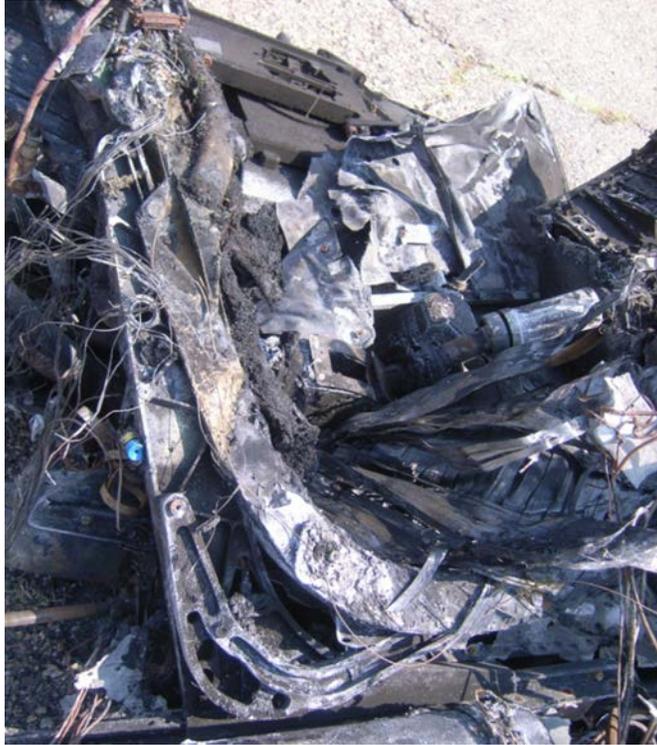
Photograph 10- On-scene photograph of the right side of the pilot seat back.

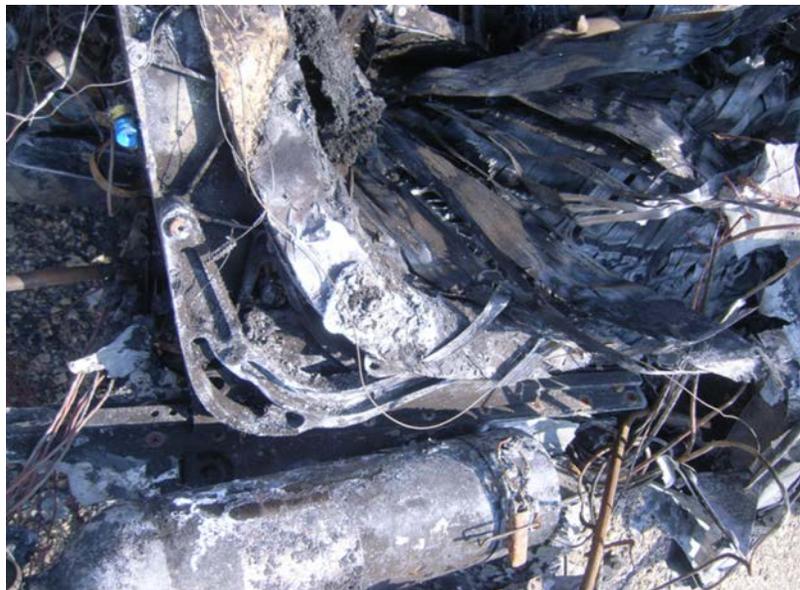
Photograph 11- Close up on-scene photograph of the seat bucket of the pilot seat.

According to Air Methods General Operations Manual (Rev 8: 3/11/14), fire extinguishers were installed in accordance with applicable FARs. Survival kits, appropriate for the season and area of operation, were also carried. Due to the postcrash fire, the location and condition of some of these items were not documented. A fire extinguisher was observed in photograph 11 of this report.

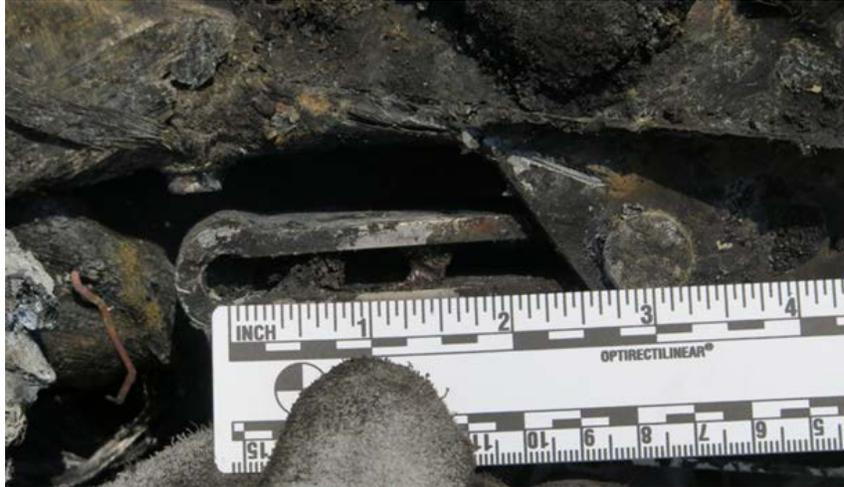
Photograph 12- Photograph of the top of the right side pilot seat.

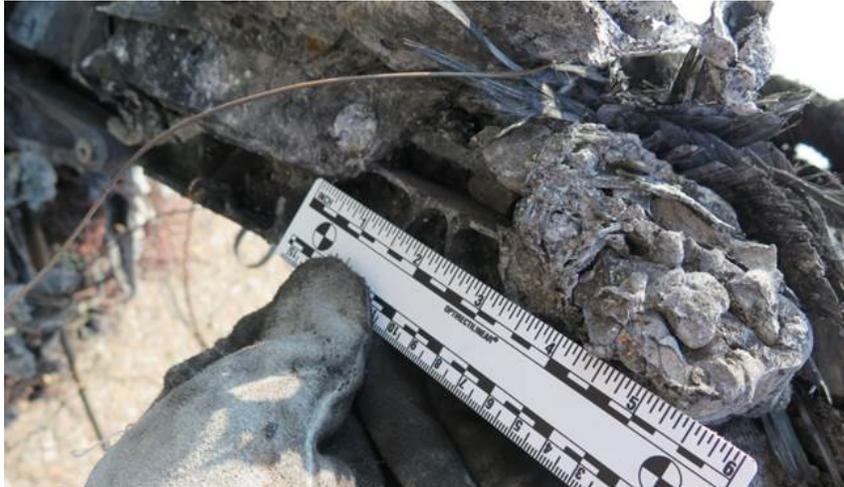
Photograph 13- Photograph of the top of the left side pilot seat.

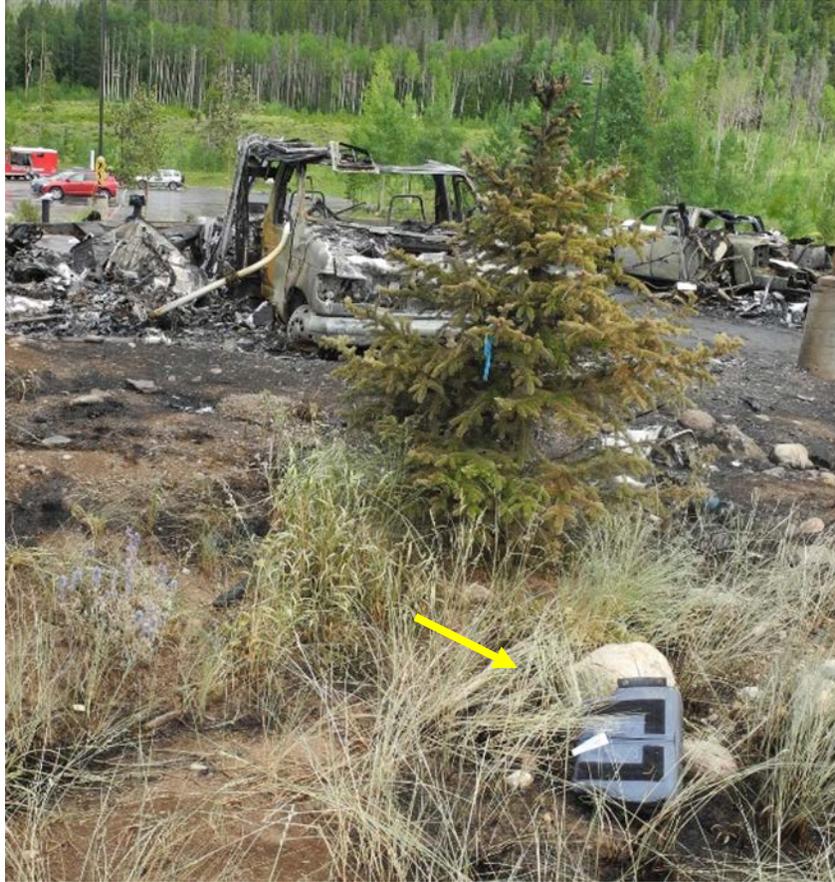
Due to the postcrash fire and the extensive damage to the fuselage, the location and condition of the two full length medical crew jumpseats could not be documented. Photographic evidence showed that the third short jumpseat was located in front of the RV and the seat pan cushion was located near a tree in the same region (see photograph 14-16). This seatpan cushion appeared not to be damaged by fire and the two snaps on each side to affix the seat cushion to the seat frame were visible. The seat frame was twisted and appeared to be damaged by fire.

Photograph 14- Photographs of the short aft jumpseat cushion.

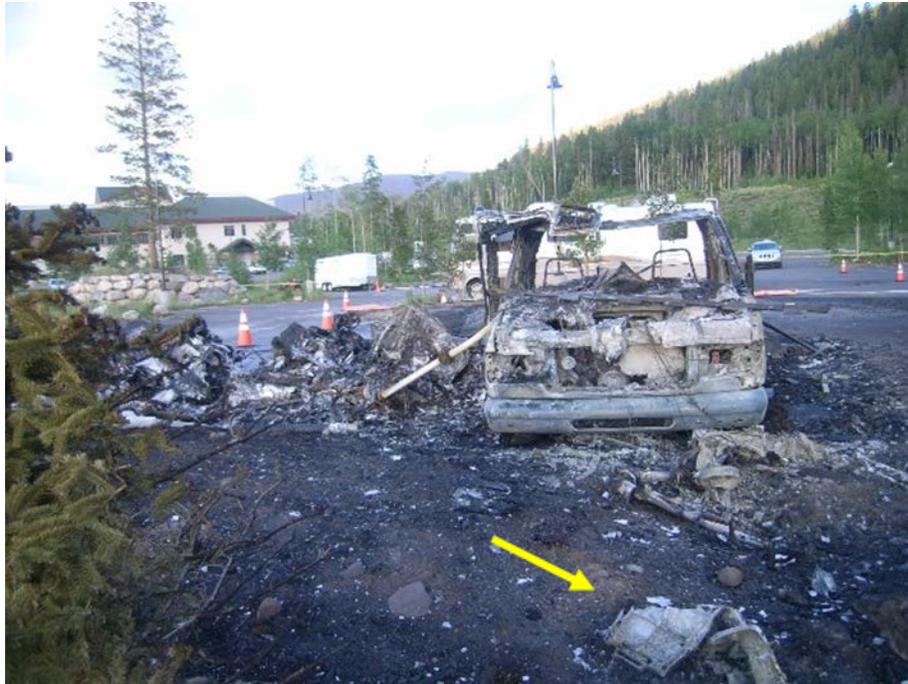
Photograph 15- Photograph of the short aft jumpseat, which was located in front of the RV.

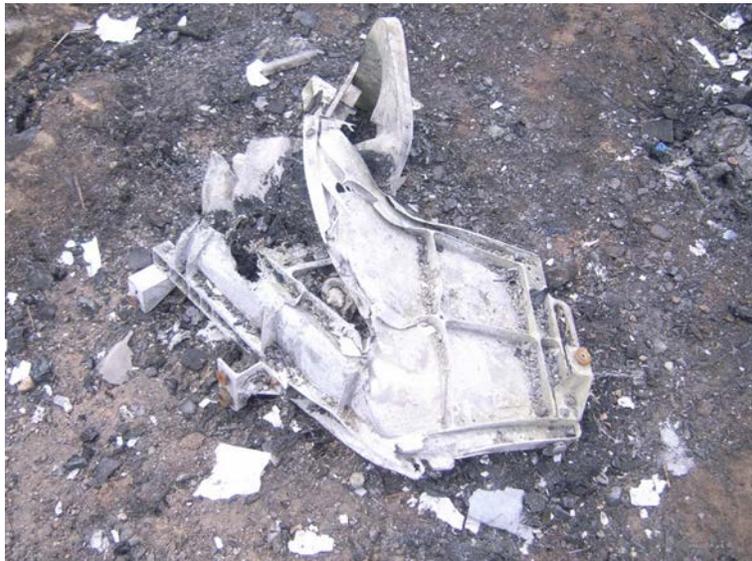
Photographs 16- Photograph of the short aft jumpseat, which was located in front of the RV.

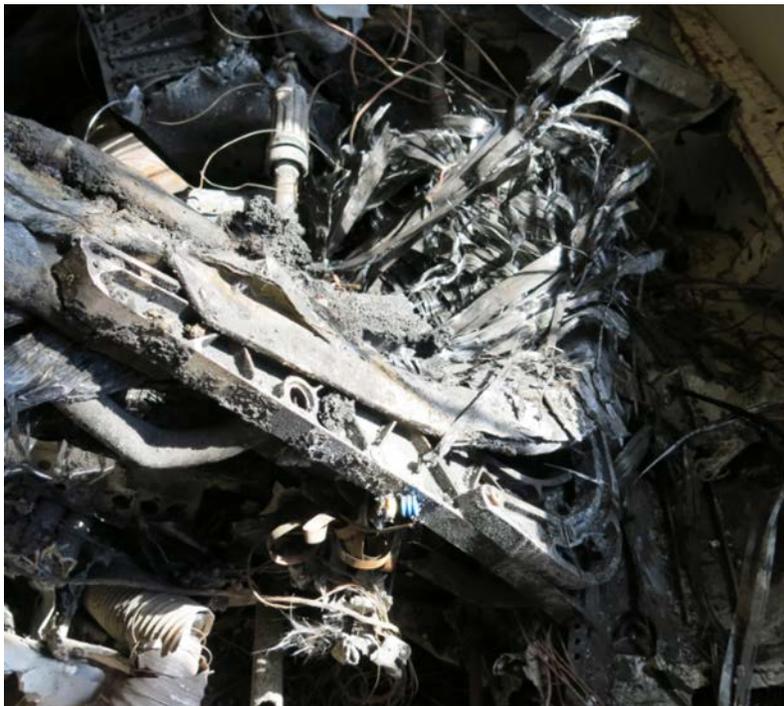
A portion of the pilot seat was still attached to the airframe. A small section of the right seat track was visible. The seat had extensive fire damage. The right side seat frame was present and intact. The left side seat frame was missing. A piece of the seat bucket was present but extensively damaged by fire. Two cross tubes behind the seatback were attached to the right seat frame. Both cross tubes were bent and sheared at the left side. The seat pan was consumed by fire. The seatpan and seatback cushions were consumed by fire. The restraints were not identified. Due to the extent of the fire damage, no measurement of seat stroke was possible.

Photograph 17- Photograph of the right side of the pilot seat as found at Beegles Aircraft Recovery.

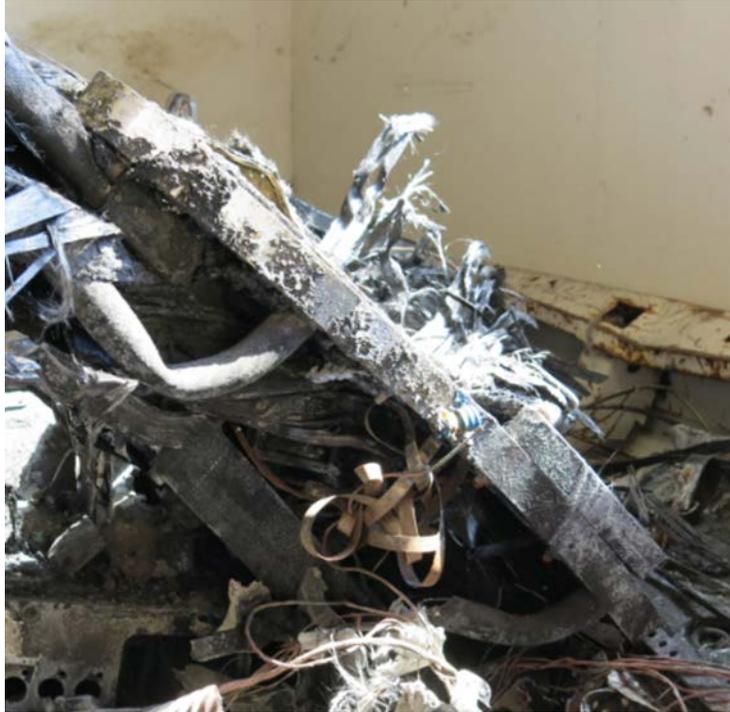
Photograph 18- *Photograph of the back side of the pilot seat with cross tubes bent and sheared at the left side as found at Beegles Aircraft Recovery.*
