**NATIONAL TRANSPORTATION SAFETY BOARD**  
**Office of Aviation Safety**  
**Washington, D.C. 20594**

**HELICOPTER SPECIALIST'S FACTUAL REPORT**

**NTSB No: ERA17LA263**

Operator: Sikorsky Aircraft Corp  
Aircraft: S-97 Raider  
Location: Jupiter, FL  
Date: August 2, 2017  
Time: 0720 eastern daylight time

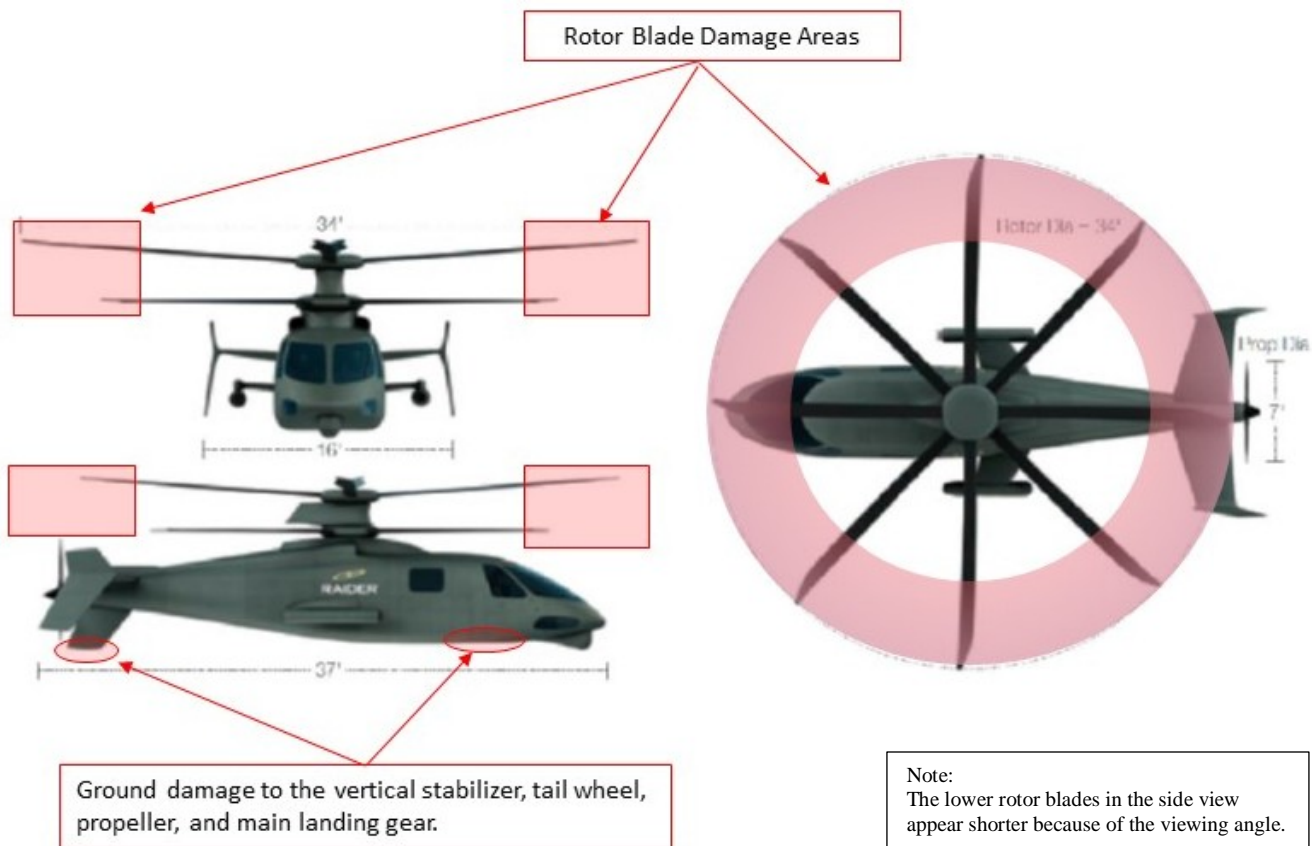
The helicopter was resting upright on the south side of the runway at the intersection of taxiway A and runway 9/27. The two main landing gear and the tail wheel had collapsed outward, with the helicopter resting on its belly. The helicopter is configured with two 4-bladed counter rotating rotors, with the rotor stacked vertically one over the other. All 8 rotor blades remained attached to their respective hubs and all rotor blade ends had been separated from each blade at approximately the same location along the length of each blade. The tail has a horizontal stabilizer with rudders attached at each end of the stabilizer in a H-configuration. The vertical stabilizers and attached rudders had fractured at the attach points on the horizontal stabilizer as a result of ground impact. A 6-bladed composite variable pitch pusher propeller was positioned at the end of the tail section. All six blade tips exhibited leading edge damage and upward bending as a result of ground contact. The tail wheel fractured at the strut mount and was displaced to the left of the central vertical tail fin.

Figure 1 - 3-view diagram illustrating helicopter damage areas.

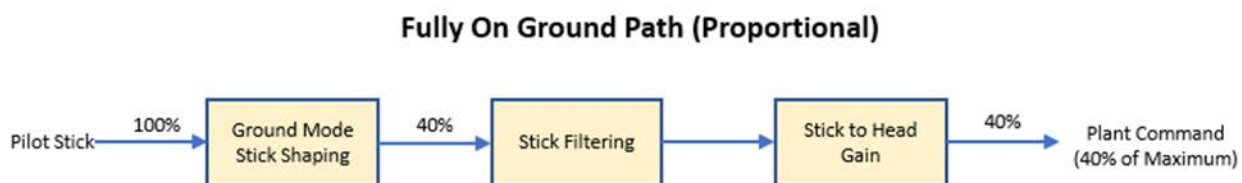
The flight control laws are divided in to three modes or paths and are referred to as the feed forward<sup>1</sup> command paths. These three paths are: fully on ground path, fully in air path, and in transition path. While the aircraft is on the ground, as detected by any one of three weight-on-wheels switches, it is in the fully on ground path (fig 2). In this mode the pilots side arm controller provides input to the rotor head proportional to the displacement of the stick (stick to head gain), such that at maximum stick deflection, the rotor head is limited to 40% of its maximum range of movement (40% attenuation factor). There is also a stick filter that removed high frequency signals from the stick and softens the connection between the stick and the swashplate.

Figure 2 - On-ground path diagram.

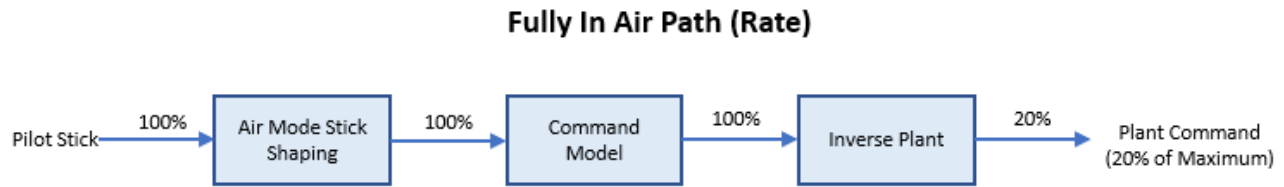
When all three weight-on-wheels switches are disengaged for more than 3 seconds, the helicopter utilizes the fully in air path (fig 3). In this mode the pilot's stick provides pitch and roll rate commands, such that stick deflection commands a rate and the rate is nulled out once the stick returns to center. The

Figure 3 – In-air path diagram

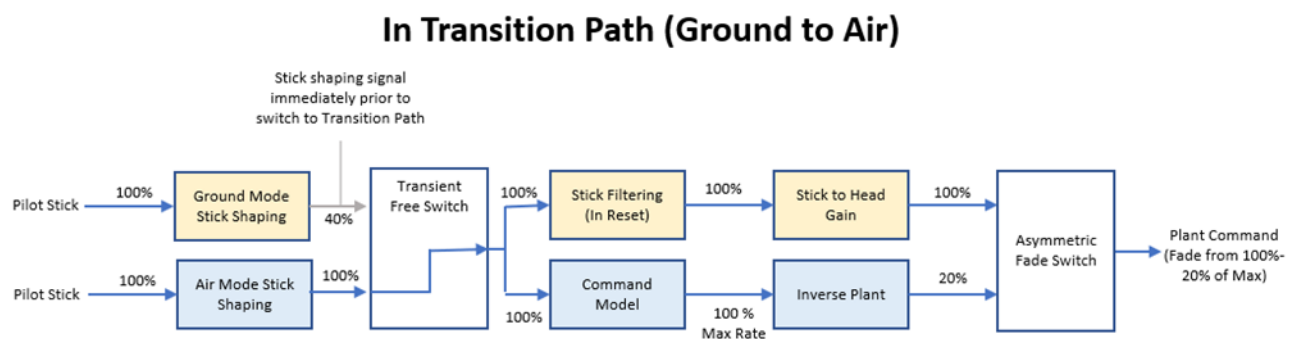
These two modes are blended during the transition from air-to-ground, or ground-to-air, creating a temporary third mode. During the 3 seconds after the last weight-on-wheel switch is disengaged, or 0.5 seconds after a weight-on-wheels is first engaged, the flight controls are in the in-transition path (fig 4). When in this mode the pilot's stick shaping is transitioning from proportional mode (ground mode) to rate mode (air mode) or vice-versa. The control laws performed this transition by using a ground mode stick shaping function, a transient free switch, stick filter, direct stick to rotor head gain on the ground path, and an air mode stick shaping function, transient free switch, command model, and inverse plant on the air path; both signals were then processed through the asymmetric fade switch which provided a single command to the roll inverse plant (flight control hardware). The transient free switch takes the difference between the newly selected stick input and the output from the previous frame, then computes a new output command at a fixed rate and adds that to the new stick input. This process is done one time and is not updated when the command signal changes. The smaller the difference, the faster the switch completes its function. The output of the transient free switch is routed through the ground path and air path simultaneously, then the two signals are blended in the asymmetric fade switch into a single command signal.

Figure 4 - In-transition path diagram.

Control law changes were introduced in late 2015 to improve ground to air transitions. The key update was changing the switch functionality at the end of the feed forward command path, from a transient free switch to an asymmetric fader switch and reset to zero the proportional path stick filter. The change from a transient free switch to a fader switch eliminated the 40% stick to head attenuation and replaced it with the full 100% proportional signal. The results of these two changes was an unintended increase of the cyclic stick sensitivity by 2.5 times during the transition to flight.

The larger than expected roll response to the pilot roll stick input was the effect of a flight control system design error that resulted in unintended changes in the pilot input sensitivity in the roll axis during the transition from ground control mode to flight mode.
