PRELIMINARY REPORT

Delray Beach, Florida

HWY19FH008

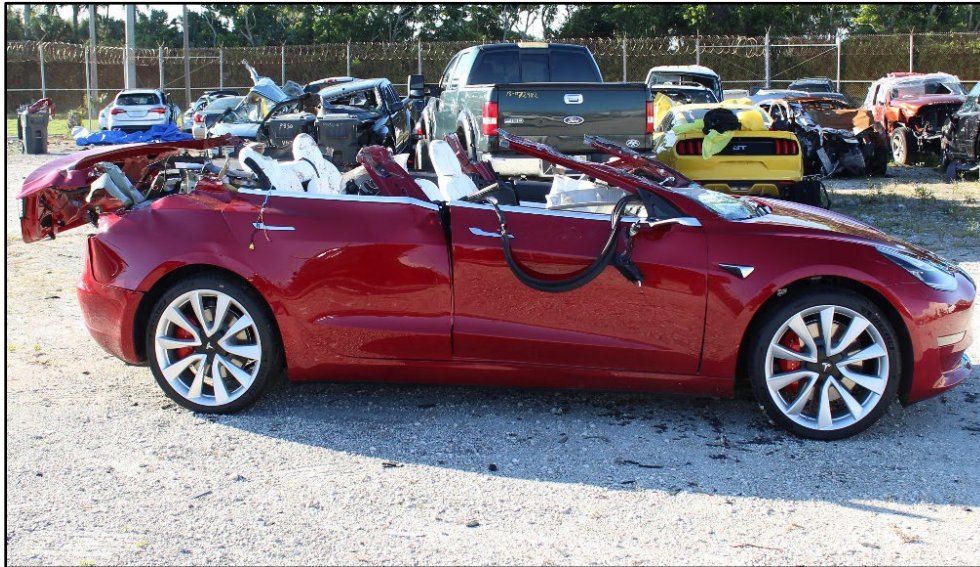
The Tesla struck the left side of the semitrailer. The roof of the Tesla was sheared off as the vehicle underrode the semitrailer and continued south (figure 2). The Tesla came to a rest on the median, about 1,600 feet from where it struck the semitrailer. The 50-year-old male Tesla driver died as a result of the crash. The 45-year-old male driver of the combination vehicle was uninjured.

Figure 2. Tesla Model 3 with extensive roof damage photographed postcrash at tow yard.
