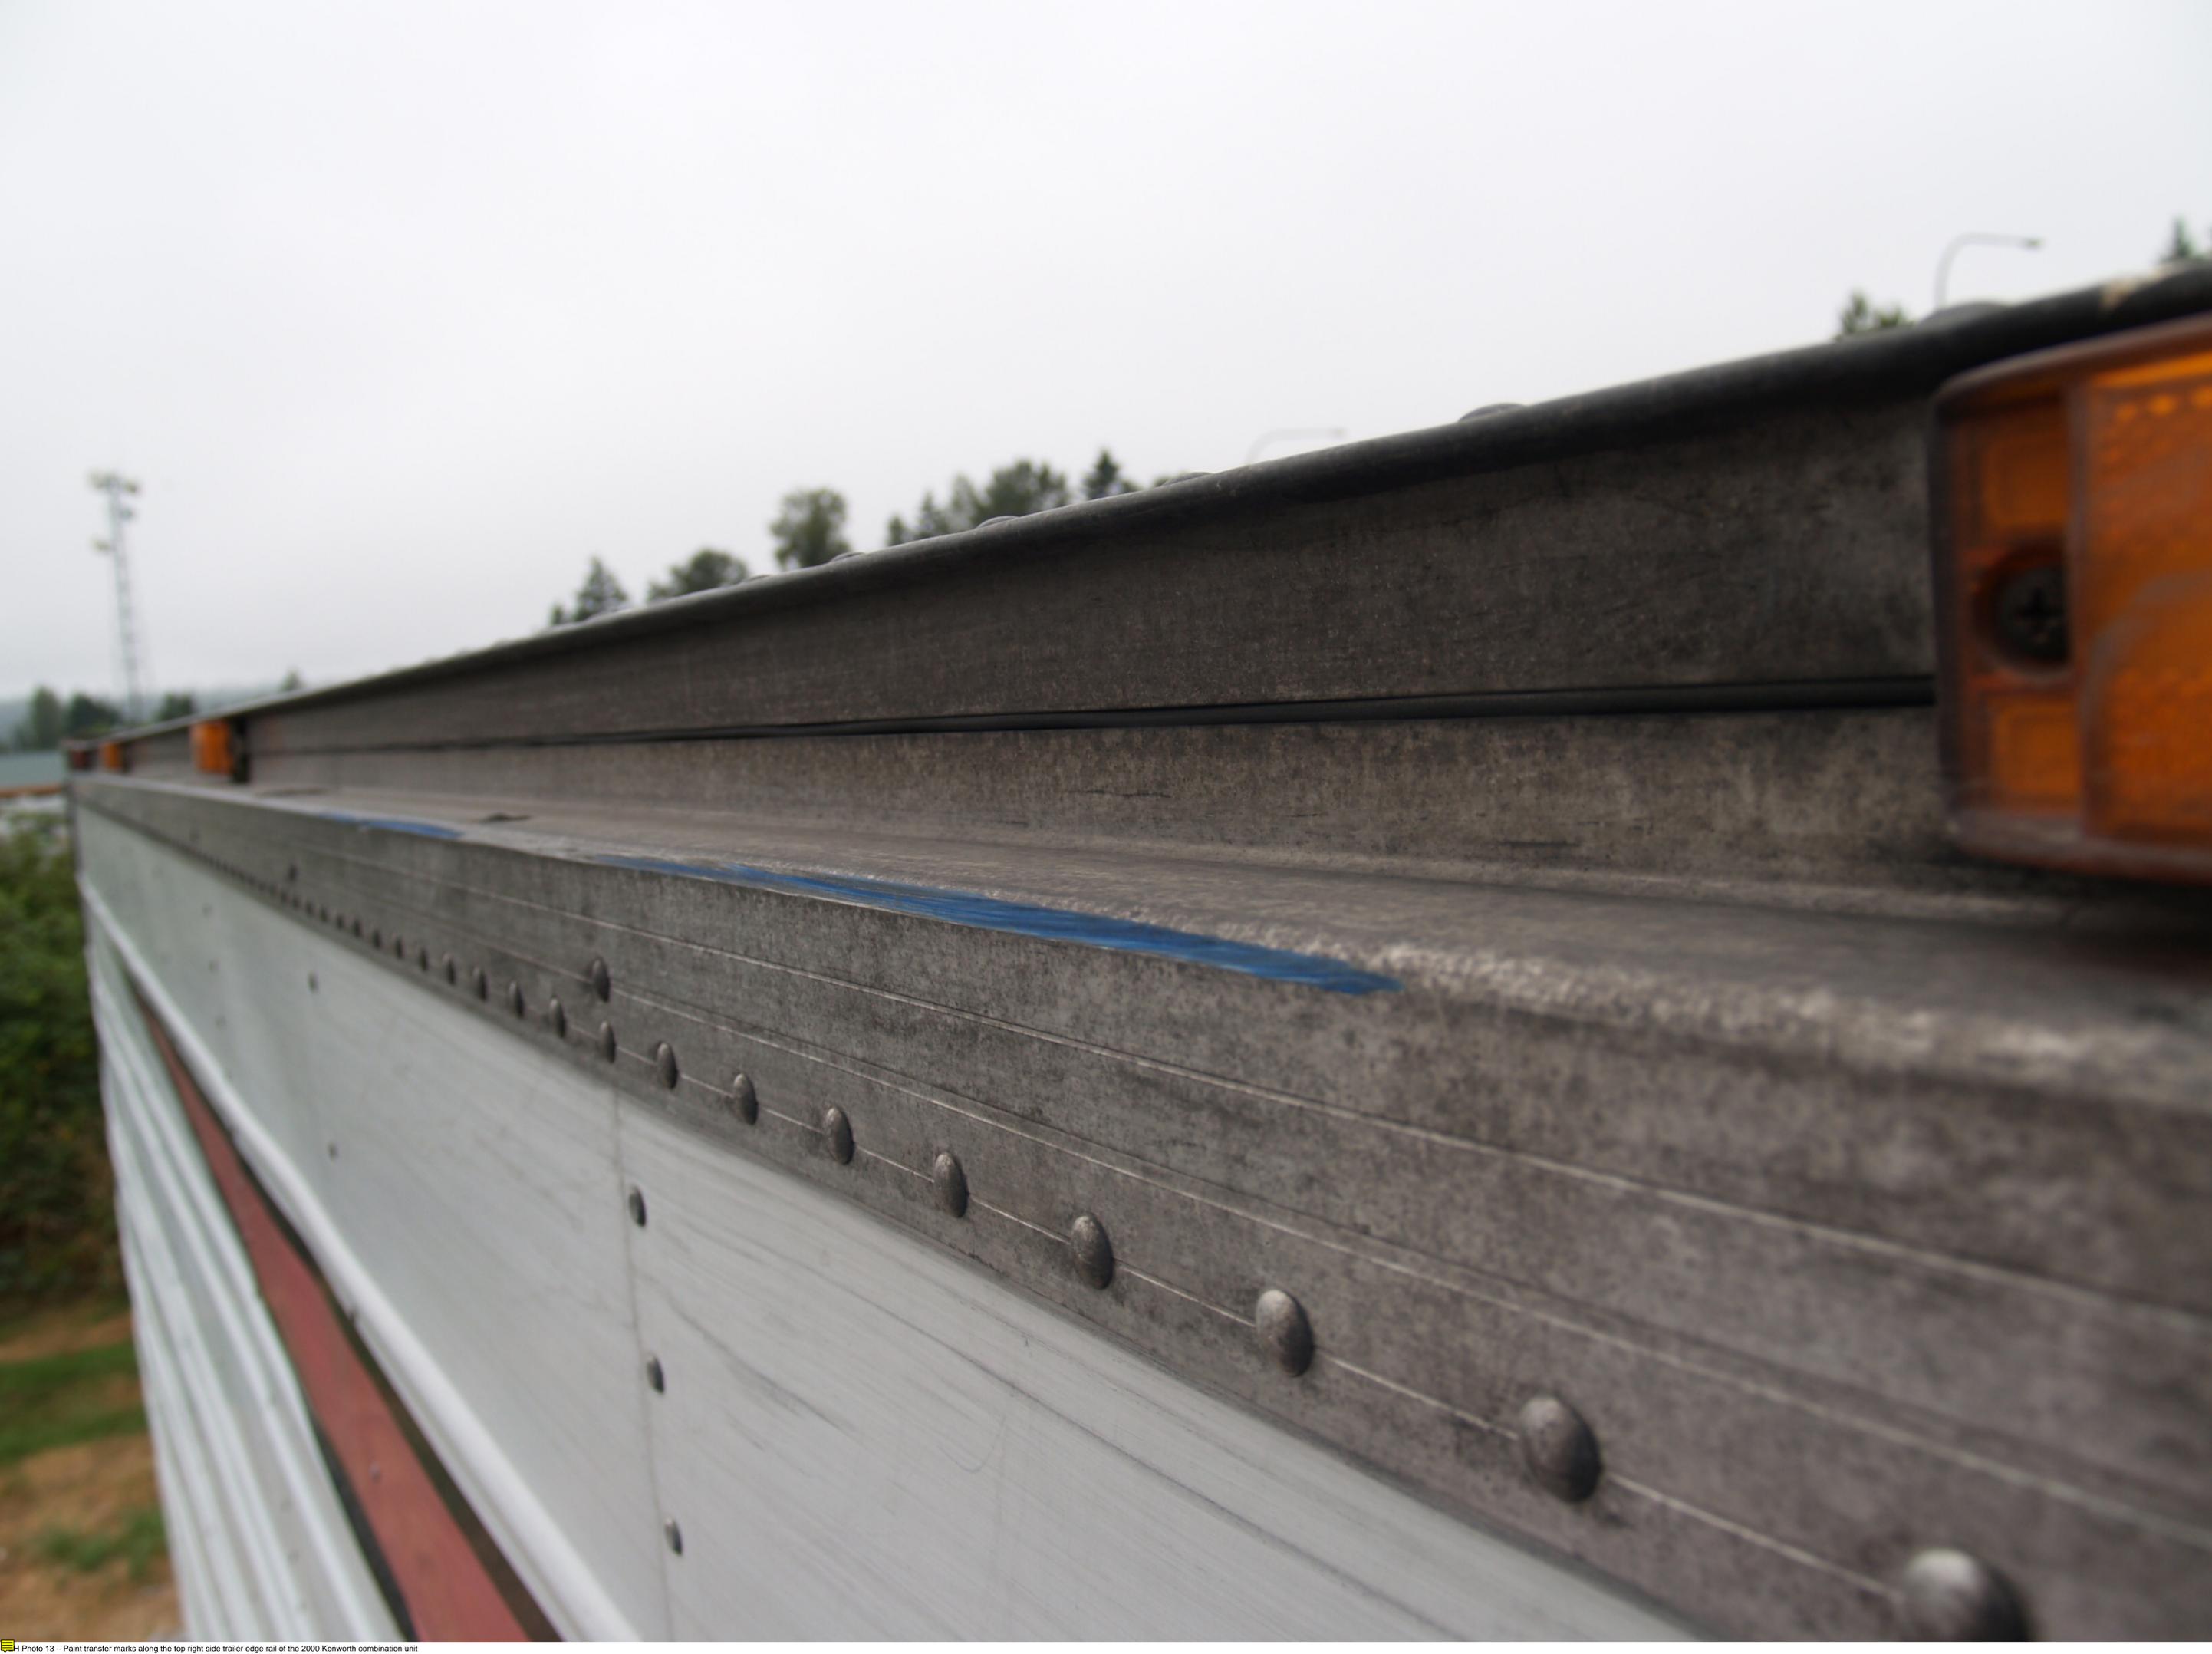
Photo 13 - Paint transfer marks along the top right side trailer edge rail of the 2000 Kenworth combination unit
