Accident Investigation Report - Pedestrian Bridge Collapse at Florida International University

UniversityCity Prosperity Project
Miami, Florida

Prepared by:
Munilla Construction Management (MCM)
6201 SW 70th Street
Second Floor
Miami, FL 33143

Prepared for:
National Transportation Safety Board

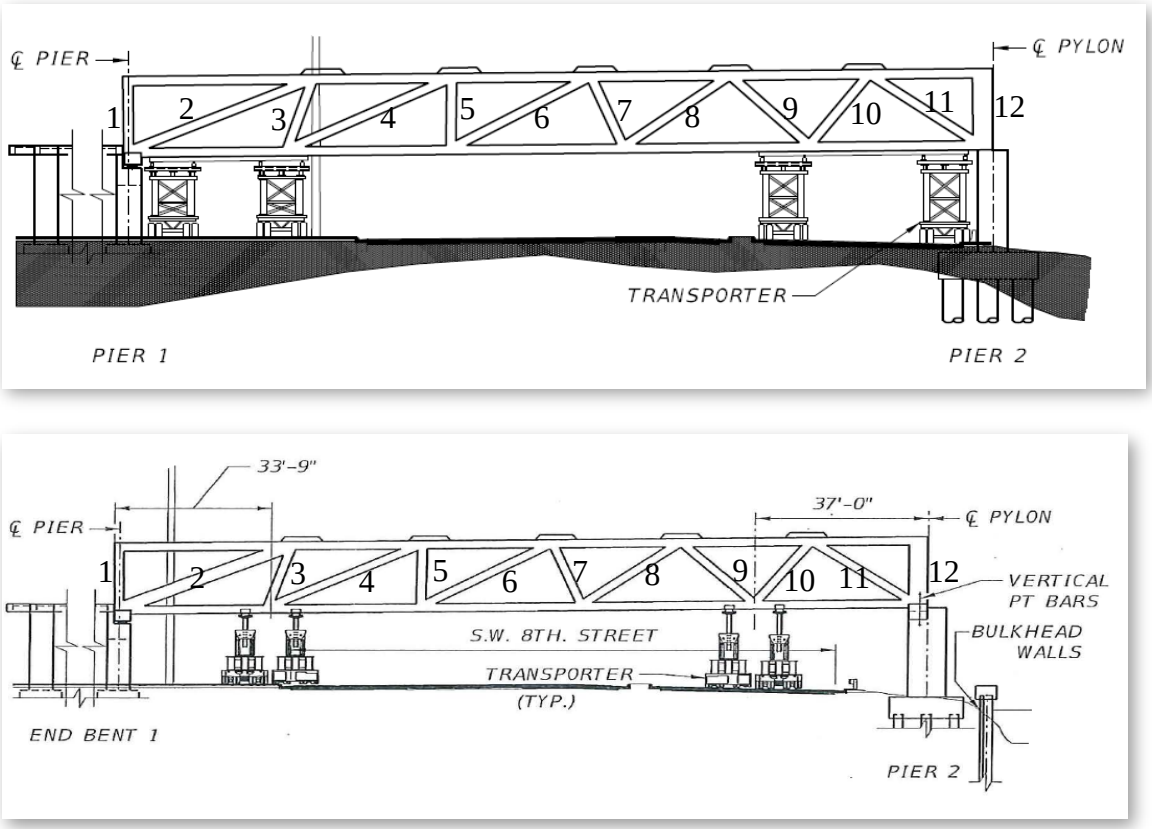
Figure 12. Placement of SPMT support: Proposal (upper) and RFC (lower).[65]

This addition meant that the large compression and shear forces created from the temporary PT in Members 2 and 11 compounded the already large compression and shear forces that existed in these elements both before and after the move. Critically, FIGG did not update its calculations (*i.e.*, interface shear friction capacity) to check this worst-case loading combination of high compression and shear from self-weight *and* PT at Members 2 and 11.[66] It is this combination of compressive forces in Member 11 and resulting shear at Node 11/12, combined with FIGG's failure to accurately verify the structural integrity of the Bridge at these locations, that led to the cracking and final collapse, as discussed in more detail in Sections 5 and 6.[67] FDOT failed to

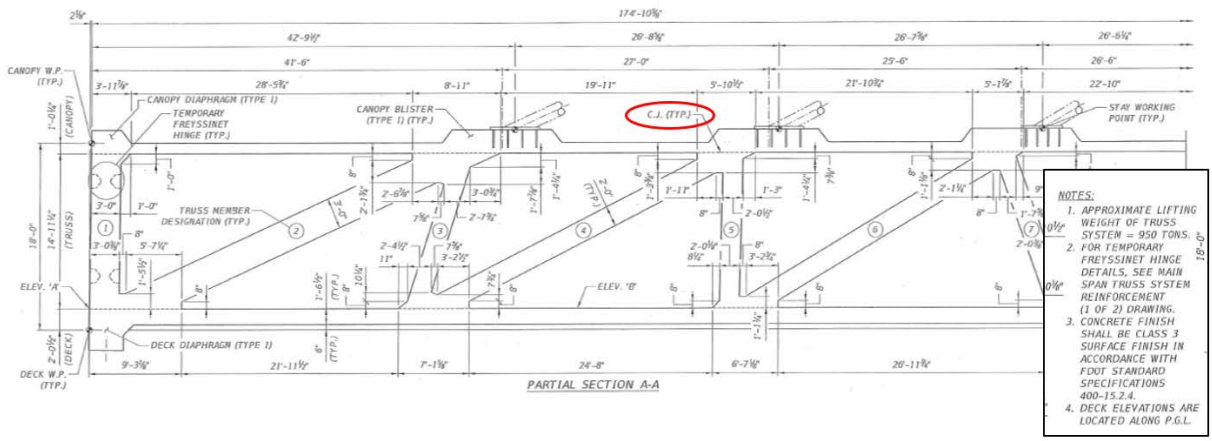
Figure 13. Main Span Truss elevation with construction joints and notes from RFC Sheet B-37.[68]

Based on this B-37 note, and the details of construction stage 2 shown on Sheet B-109, FIGG anticipated and allowed the placement of the Deck concrete to be completed prior to the placement of the Truss Web Member concrete and expected that the Canopy concrete would be placed after the Truss Web Member concrete (thereby creating construction joints). However, FIGG did not provide any instructions regarding surface roughening amplitude at these construction joints, despite the fact that Eddy Leon of FIGG stated in his NTSB interview that intentional roughening is usually called out on the plans when it is intended in the design.[69]

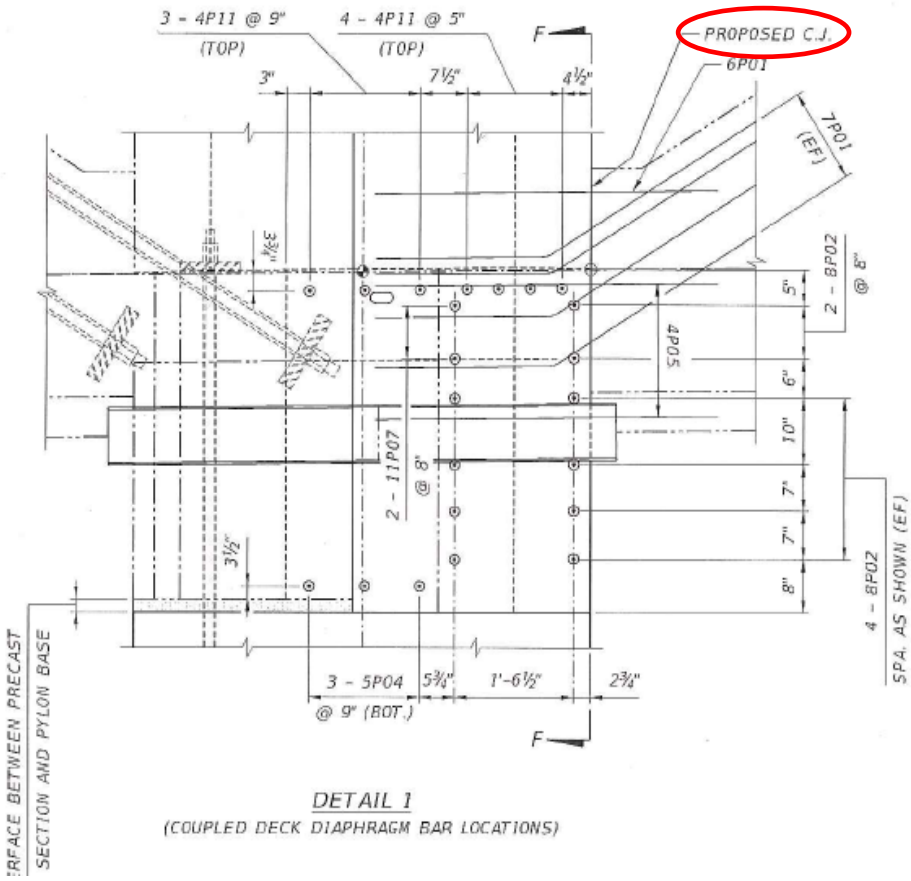
Figure 14. Excerpts of detail with construction joint and notes from RFC Sheet B-24B.[72]

Notably, two Substructure drawings (RFC Sheets B-24B and B-25) identify concrete construction joints in the Pylon Diaphragm. By contrast, in these instances, the notes on the drawing <u>do</u> supply further information and <u>explicitly state that the proposed construction joint "shall be roughened to an amplitude of ¼"</u> prior to casting back span." Excerpts of construction joint detail and the accompanying notes from Sheet B-24B are shown in Figure 14 below.

Similarly, for the construction joint between the concrete bearing seat and the top of the end bent in Sheet B-104, FIGG specified a surface roughness amplitude of 1/8-inch.[70] FDOT reviewed all of these drawings and did not take any exception to three different types of specifications[71] for surface roughening amplitude.

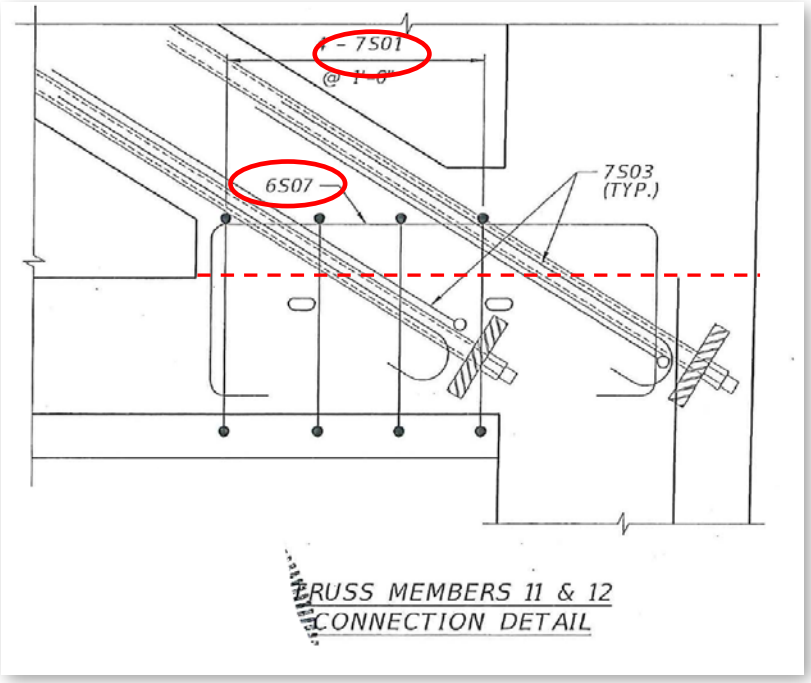
Figure 15. Reinforcement in Node 11/12, Deck construction joint indicated with red dashed line.[74]

The mild steel reinforcement in the Truss nodes for Members 11 and 12 located at the Deck elevation are shown in Figure 15 and Figure 16. Bars 7S01 are hat-shaped bars placed transverse to the Bridge length, and Bars 6S07 are approximately u-shaped bars placed parallel to the axis of the Bridge. The leading numeral in the bar designations indicate the size of the bar. The drawing excerpt in Figure 16 shows that the 6S07 bars were not to be placed within the bends at the tops of 7S01 bars but were to be located more centrally in the nodes.

In summary, the 7S01 bars crossing the construction joint at Node 11/12 were not designed to be embedded in concrete deep enough to allow development of their full strength. Therefore, shear strength calculations at Node 11/12 that involve any contribution from 7S01 bars should have considered a reduced capacity of these bars. Accurate estimation of shear capacity at Node 11/12 is essential for explaining the cause of the observed cracking and failure in and around construction joint at Node 11/12. These calculations are discussed in Section 5.

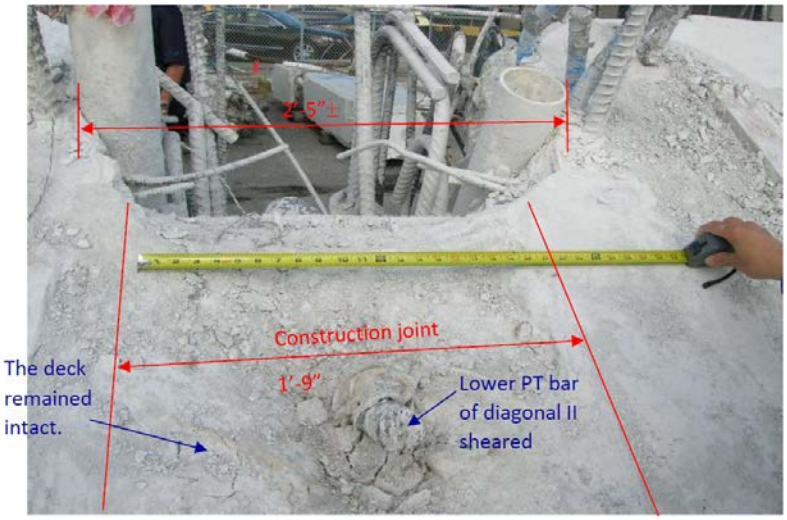
Figure 32. Post-collapse image of the joint between Node 11/12 and the Deck.[103]

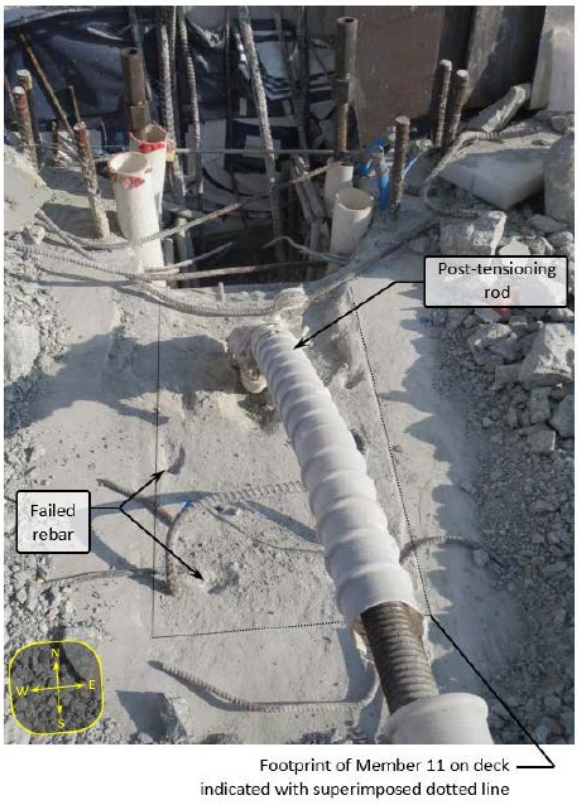
Figure 33. Post-collapse image of the joint between Node 11/12 and the Deck.[104]

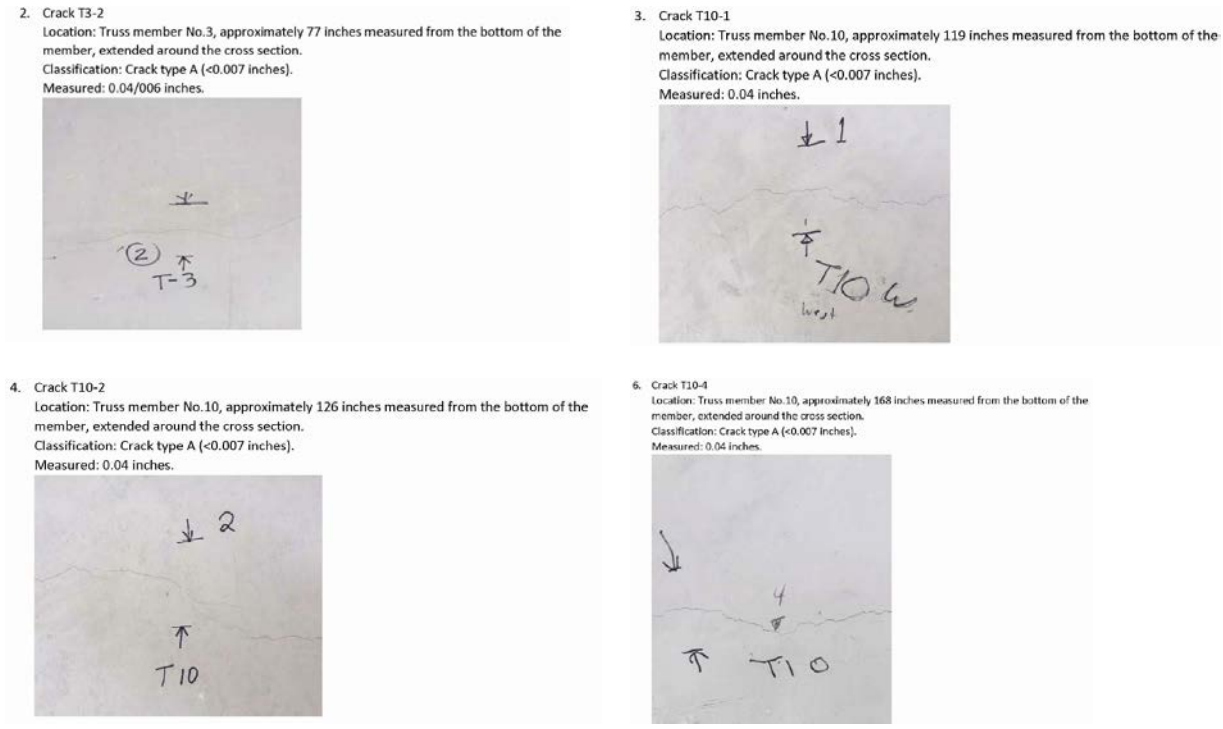
Figure 35. Cracks in Truss Members 3 and 10 on February 6, 2018, after application of PT in Members 2 and 11.[114]

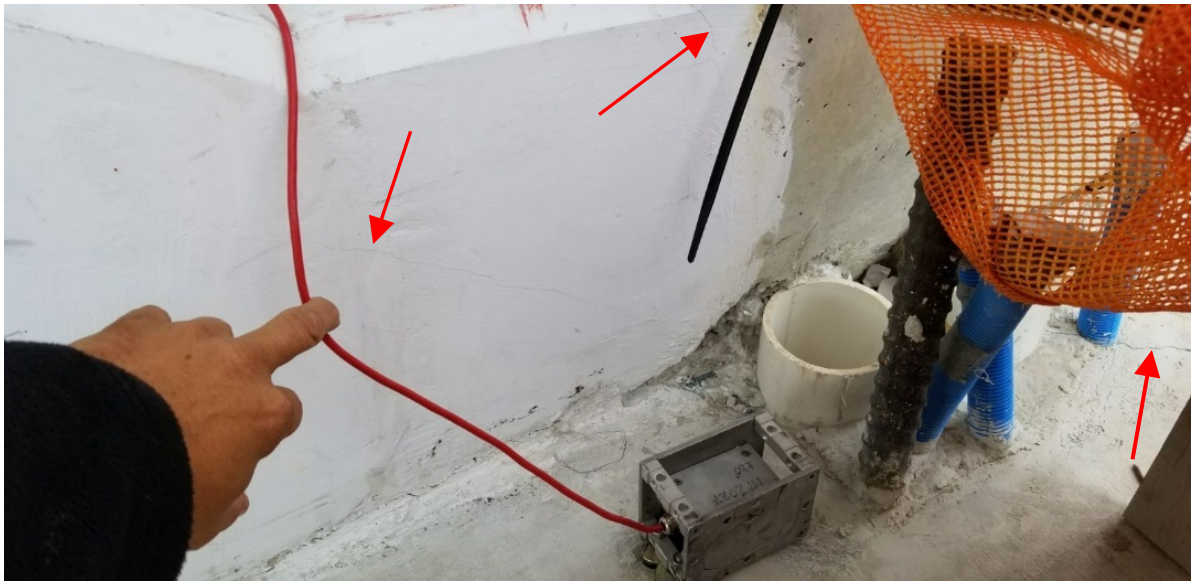
After the Bridge was installed, BPA observed cracks in Node 11/12 *before* the destressing of the PT bars in the end Diagonals (Figure 39). A frame from a video of the Main Span just after erection shows diagonal cracks under Member 11 at the south end of Node 11/12, which had been repaired prior to the move. Cracks near Node 11/12 did not open during and immediately after the move (Figure 40).

Figure 39. Cracks in and near Node 11/12 after erection and before destressing of Member 11 PT (indicated with red arrows).[128]

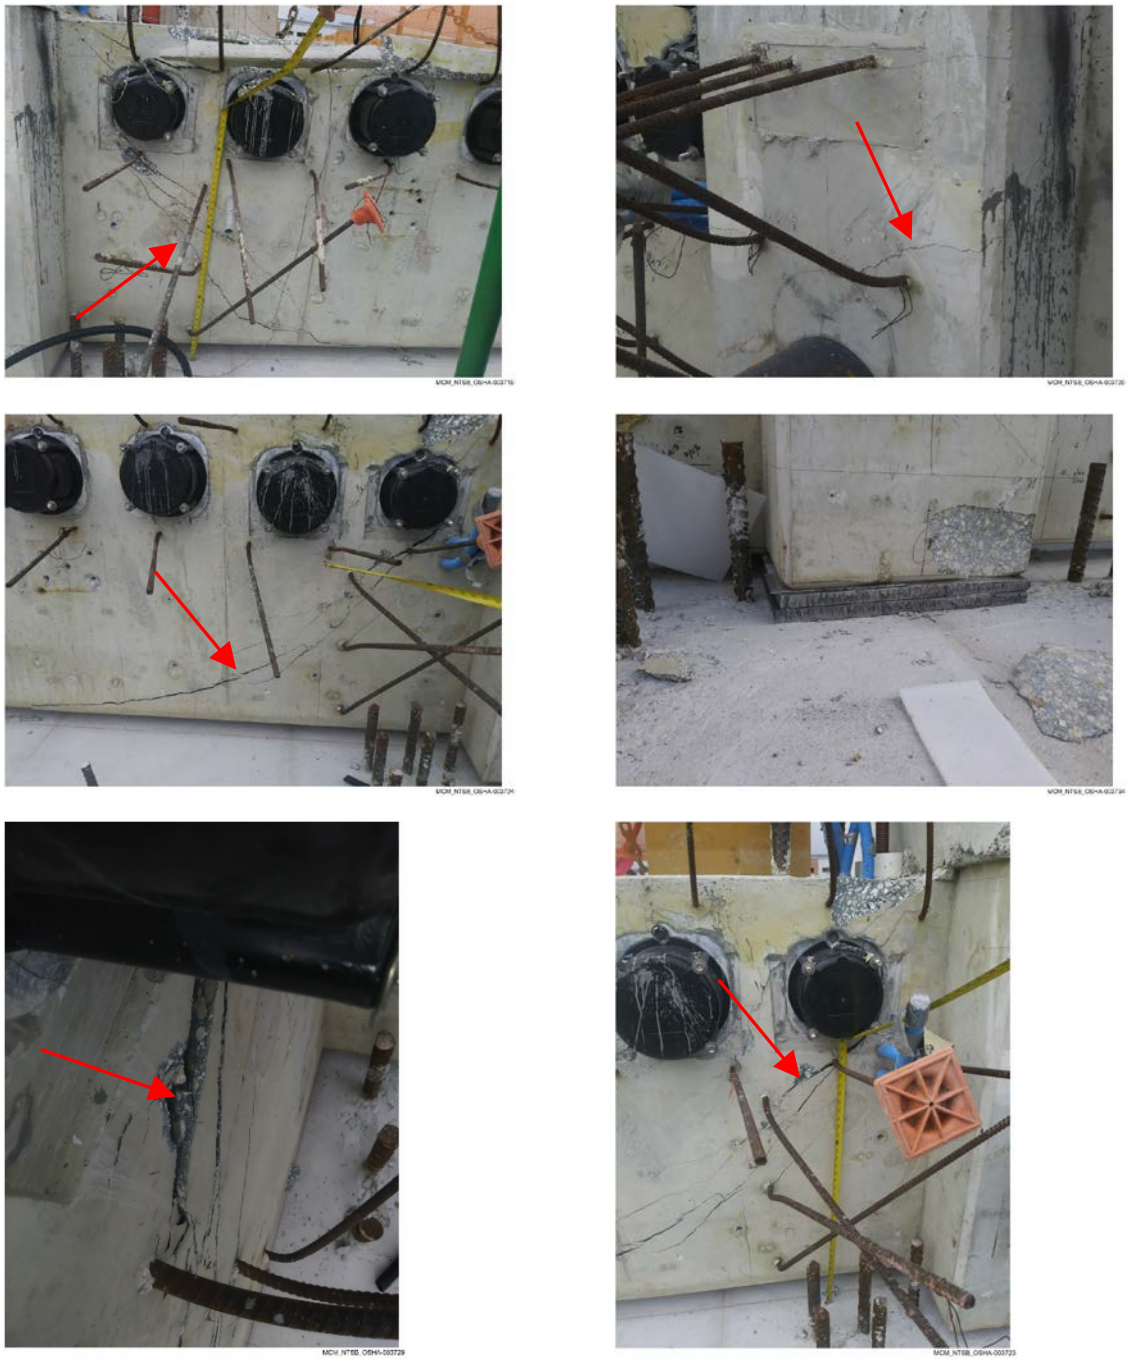
Figure 44 shows the condition of the Type II Diaphragm at the north end of the Main Span after erection of the Main Span and destressing of PT bars in Members 2 and 11.

Figure 44. Type II Diaphragm condition after erection and destressing (indicated with red arrows).[153]

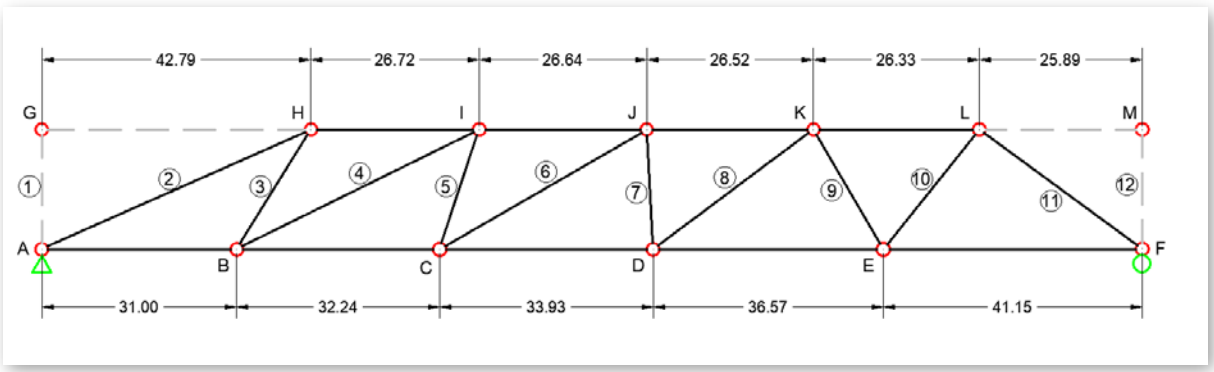
Figure 45. Idealized Main Span Truss.

In its Simply-Supported condition, the Main Span's member loads could be reasonably approximated as an ideal truss,[188] which allows the magnitudes of the forces in the end diagonals to be computed with reasonable accuracy using hand calculations. Under ideal truss assumptions, Truss Web Members 1 and 12, as well as the end Canopy segments, would be "zero force members," meaning they would not carry any significant axial force. Figure 45 shows the configuration of the Truss under ideal assumptions.

In this case, most of the Bridge's weight reaches the end supports (nodes A and F in Figure 45) by passing through end Diagonal Members 2 and 11. Only the weights of end vertical Members 1 and 12 and half of the end Deck and Canopy segments would reach the supports without first passing through the end Diagonals Members. Therefore, of the 1900-kip (950 ton) weight of the Main Span, all but 360 kips (180 tons) must pass through Diagonal Members 2 and 11 as compressive force. If the remaining 1,540 kips is evenly distributed between the north and south supports, the nominal dead load axial forces in Diagonal Members 2 and 11 would be approximately 1,890 kips and 1,450 kips, respectively, excluding the effects of PT. Adding the prescribed 560 kips of PT in each of these Diagonals, as set forth in FIGG's design plans,[189] increases the nominal axial compressions to 2,450 kips and 2,010 kips, respectively.

The axial force in Diagonal Member 11 can be resolved into vertical and horizontal components. The horizontal force is the critical component here because it contributes to interface shear in the Truss-to-Deck connection. The nominal horizontal component of the diagonal axial force is 1,710 kips for Diagonal Member 11. This horizontal force must be resisted by shear friction at Node 11/12, . As discussed later, the value of 1,710 kips for interface shear at Node 11/12 arrived at by simple hand calculation greatly exceeds the value of 571 kips that FIGG extracted from its LUSAS finite element model (*see* Section6.2.1). A hand analysis should have thus revealed to FIGG that it had greatly underestimated the shear force at this critical connection.

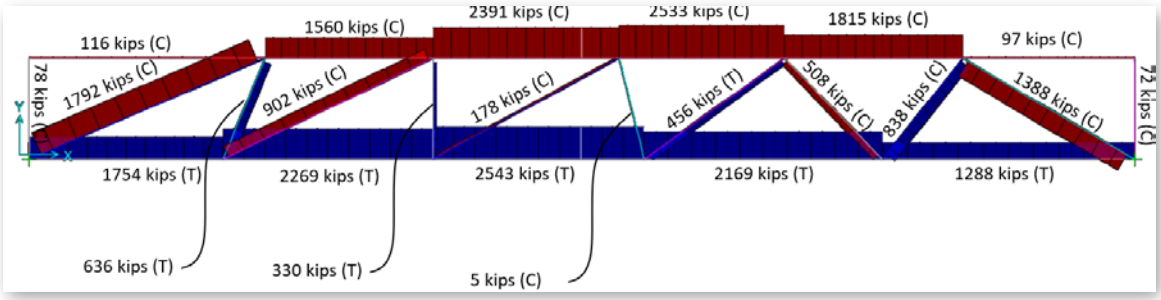
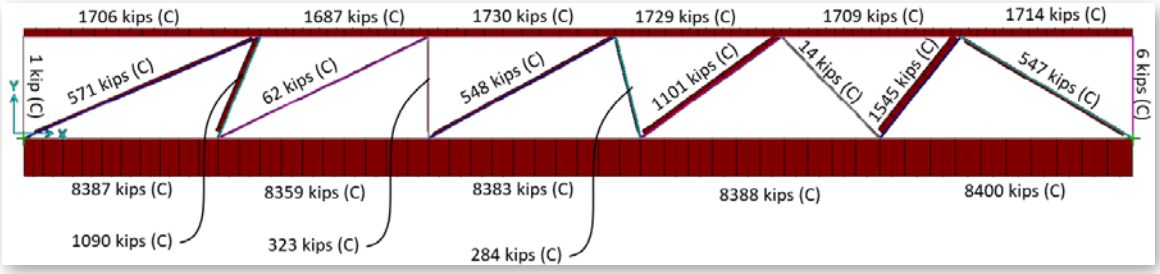
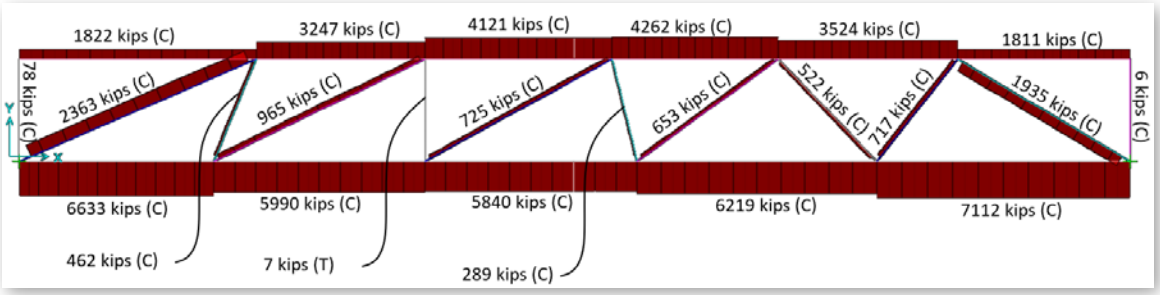
Figure 46. SAP2000 Analysis Nominal Axial Force Results for Simply-Supported Main Span.

As illustrated in Figure 46, our team then used SAP2000 to compute forces in members of the Main Span in its Simply-Supported conditions.[190] Most pertinently, member axial and shear forces were used to evaluate the interface shear at Node 11/12. This analysis is more accurate than simple hand calculations because it does not require the idealizations and assumptions needed to quickly evaluate an ideal truss, and because the rotational restraint at joints, precise distribution of weight, and effects of PT can be explicitly included in the analysis.

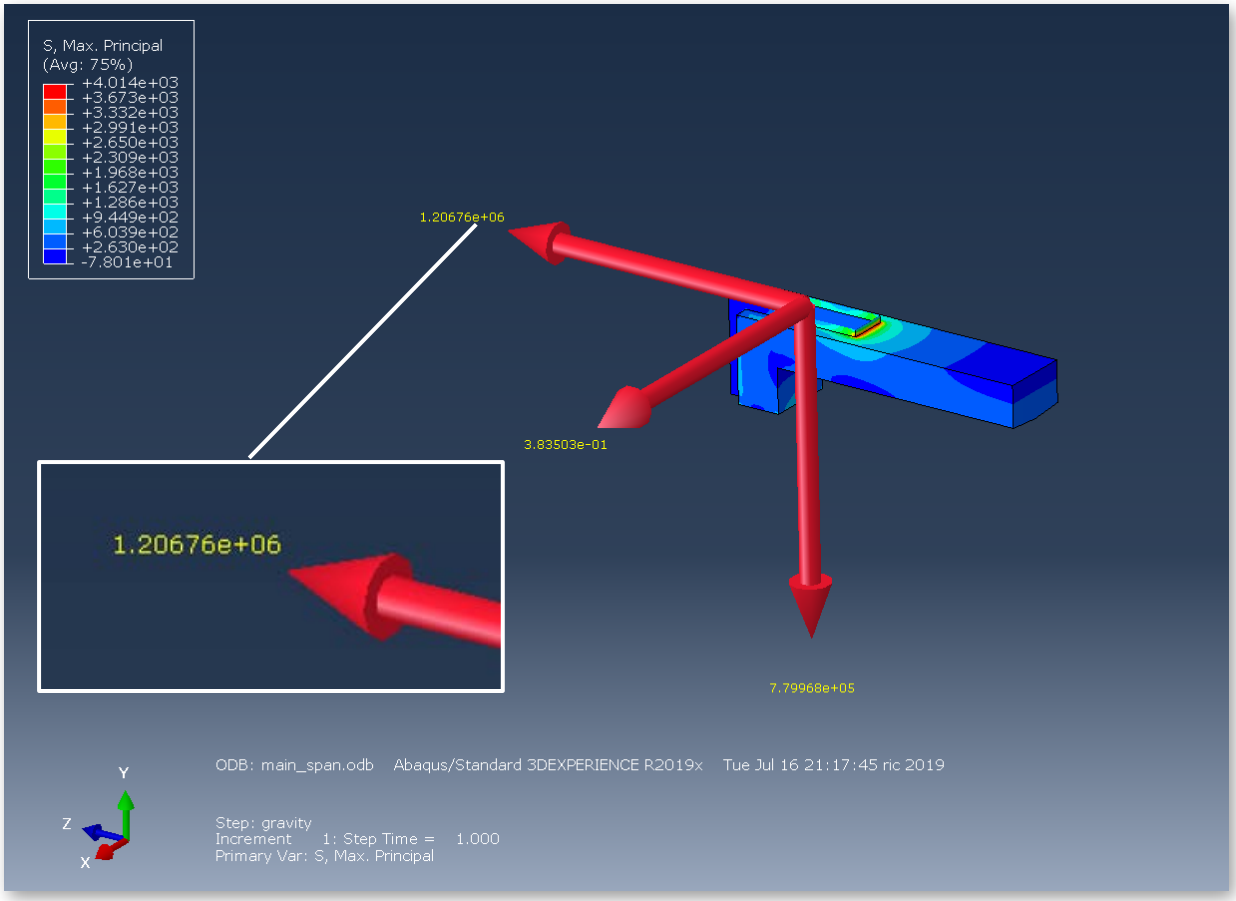
Figure 48. Node 11/12 interface shear force extraction from ABAQUS (DL only).

Figure 47 shows a rendering of the ABAQUS model with color contours of principal stress, and Figure 48 shows the directly-extracted interface shear force (reported in pounds) just above the Deck at the bases of Members 11 and 12 for nominal dead load ("DL") with no PT. This nominal DL interface shear value from ABAQUS combined with the effect of PT from hand calculations resulted in a total nominal interface shear value of 1,686 kips, which corresponds with 1,710 kips and 1,738 kips from hand calculations and SAP2000 analysis, respectively.

Interface shear at Node 11/12 from all three models are within 3% of each other, demonstrating the utility and accuracy of each model in this analysis.

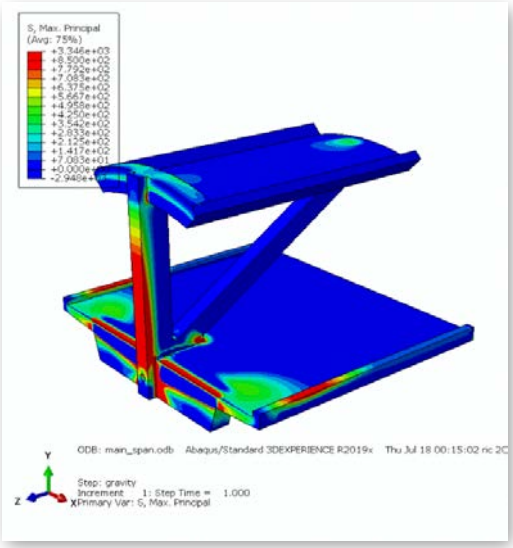
Figure 50. Principal stresses from refined ABAQUS model.

Figure 50 shows the resulting contours of principal stress. Any color warmer than blue indicates the presence of some tensile stress. Red colors indicate principal tensile stresses over 850 psi, which corresponds to the approximate threshold for concrete cracking in the Superstructure.

According to this analysis, cracking was anticipated on the north side of Member 12, at the south corner of Node 11/12, and on the north face of the Type II Diaphragm. These results are validated by the observations of cracks prior to collapse, as shown in Figure 51 and Figure 52. The extent of the flexural cracks on the north face of Member 11, however, raises questions about the adequacy of the design of this Member that will be addressed in Section 6.

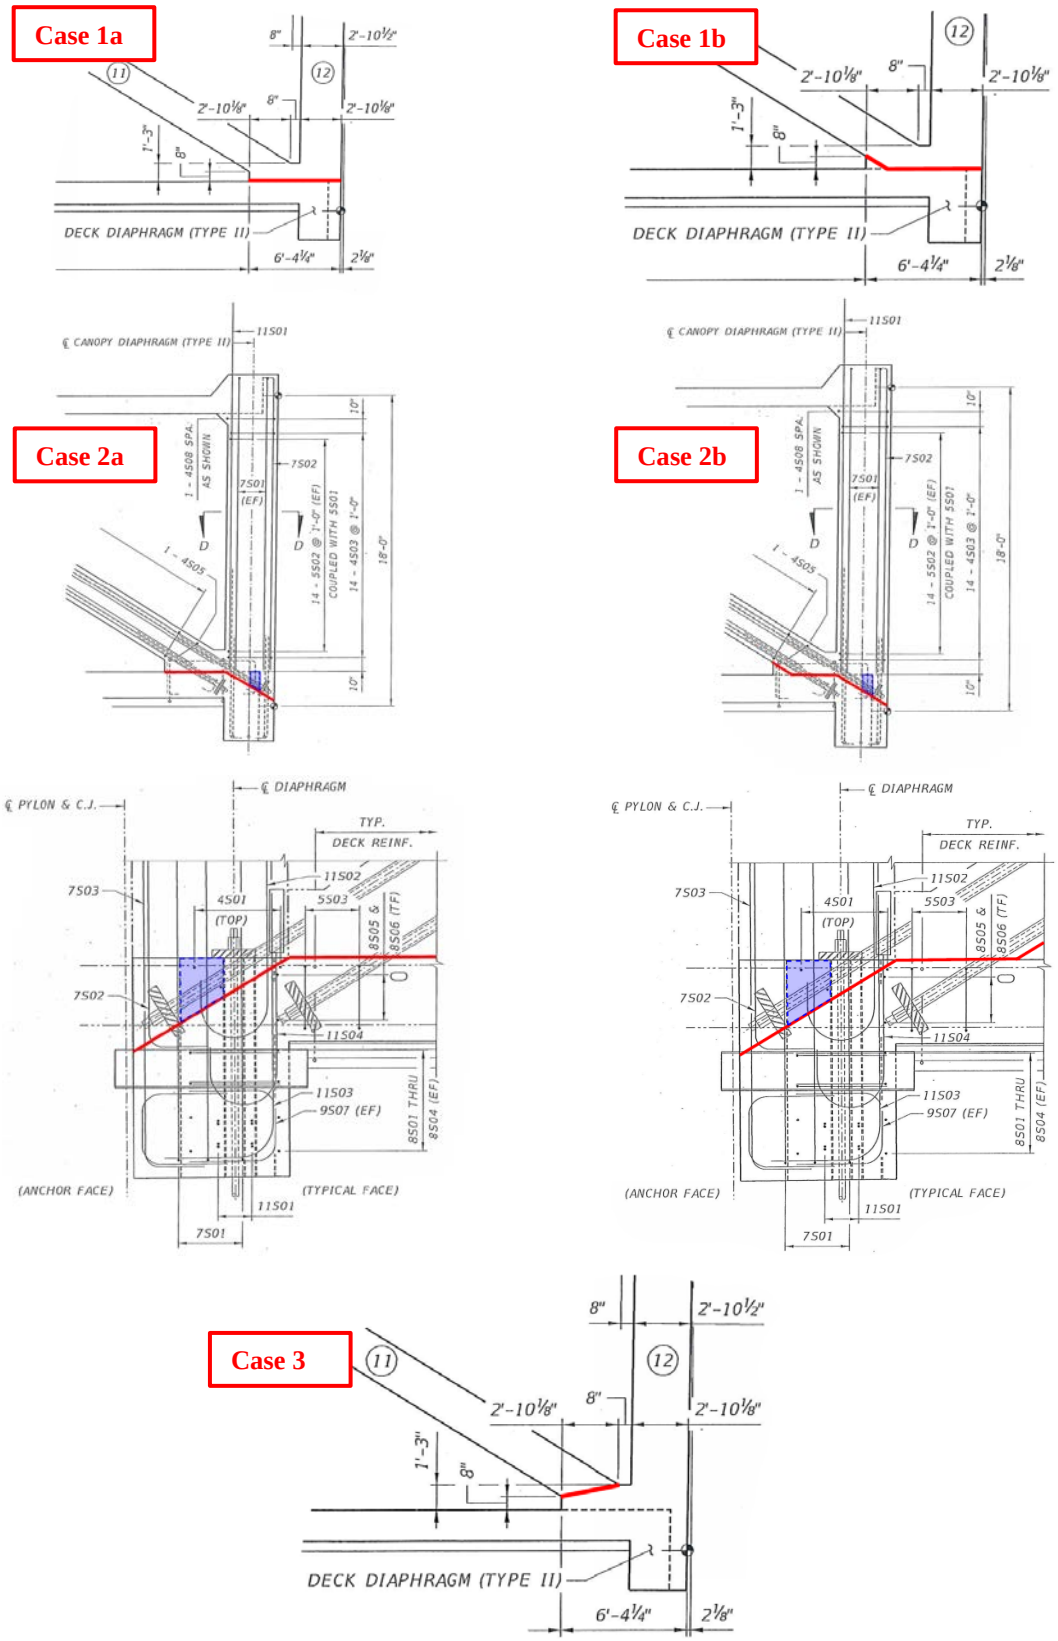
Figure 56. Interface shear failure surfaces.

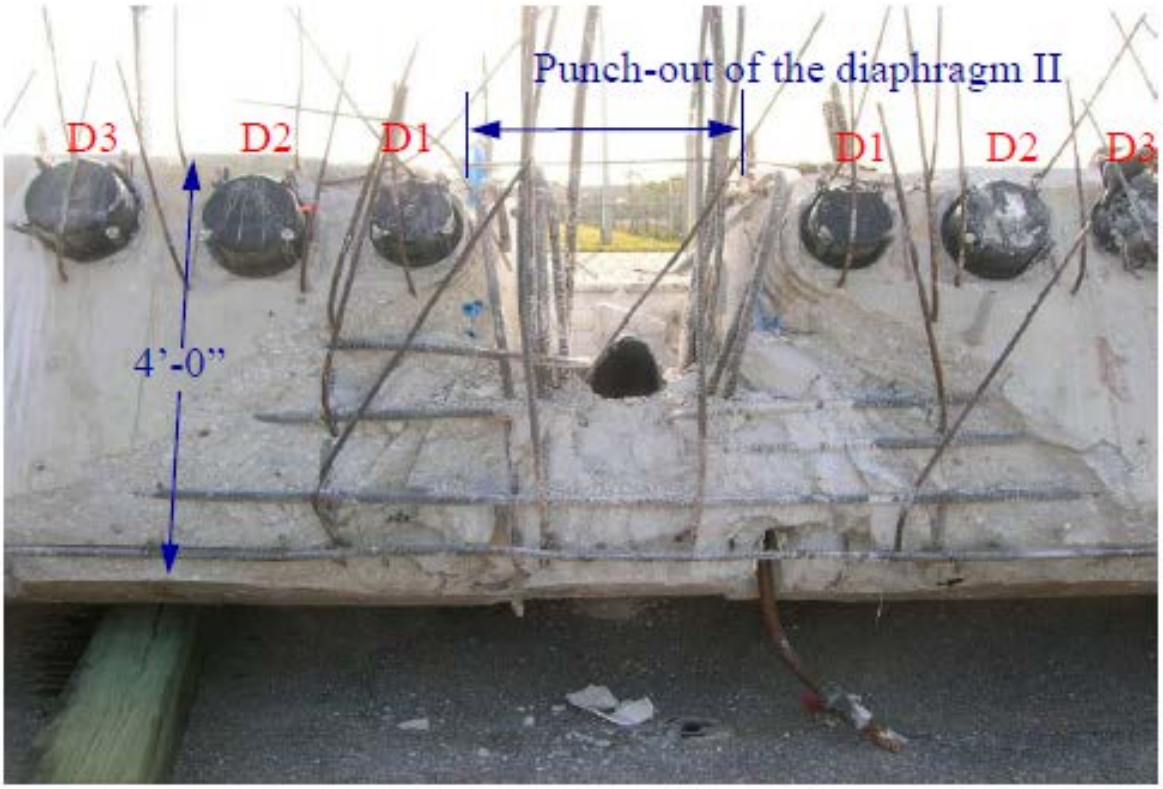
Figure 60. Fractured surfaces in Type II Diaphragm.[202]

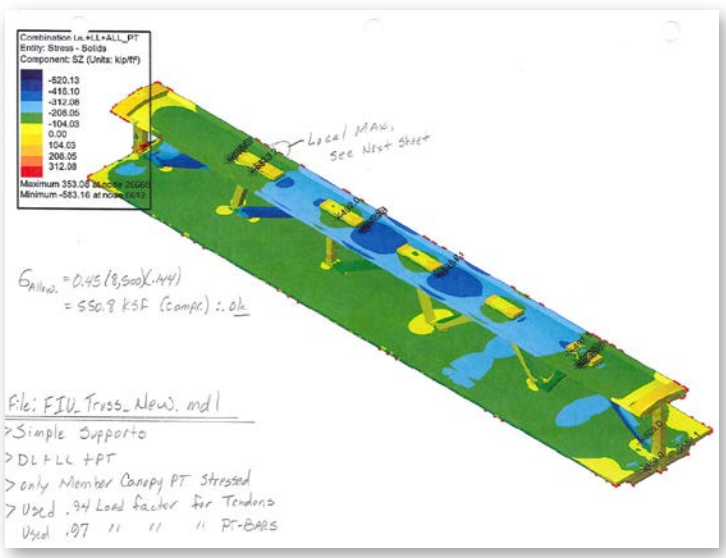
Figure 61. Hand-annotated LUSAS model screenshot.[215]

Figure 61 shows the longitudinal normal stress contours for the Simply-Supported Main Span, indicating that dead, live, and PT loads were applied to the model. However, there is no indication that the construction loads specified in FIU's Design Criteria Section 4.10 were included in FIGG's design calculations, which would have increased the design loads and resulting stresses.

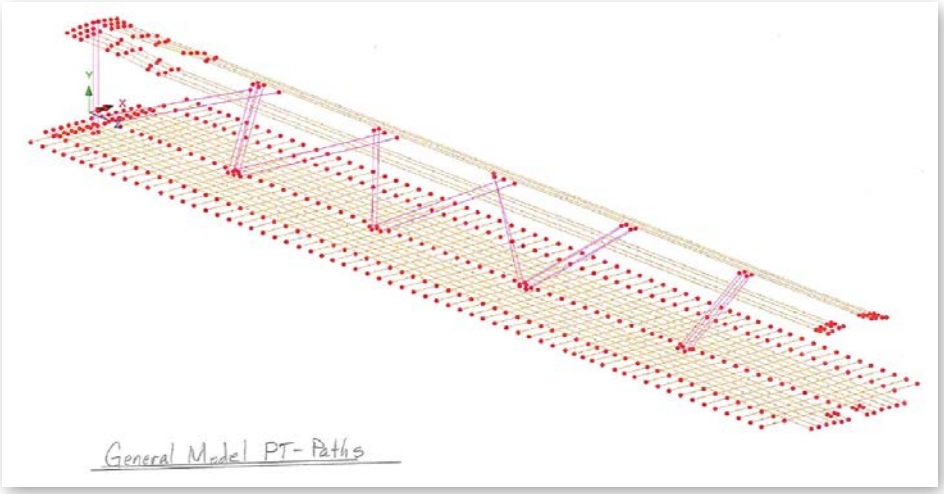
Figure 62. LUSAS screenshot showing PT paths for Simply-Supported Main Span.[216]

Further, Figure 62 shows the locations of PT tendons modeled in the Simply-Supported Main Span. However, PT bars are notably shown in Diagonal Member 2 on the south end of the span, but not in Diagonal Member 11 on the north end of the span. Figure 62 also shows PT bars located in vertical Member 1 and Diagonal Member 4, contrary to RFC drawing Sheet B-38 and the installation in the field. In other words, this arrangement of PT bars does not represent the condition of the Main Span prior to its collapse on March 15, 2018 and is thus unreliable.

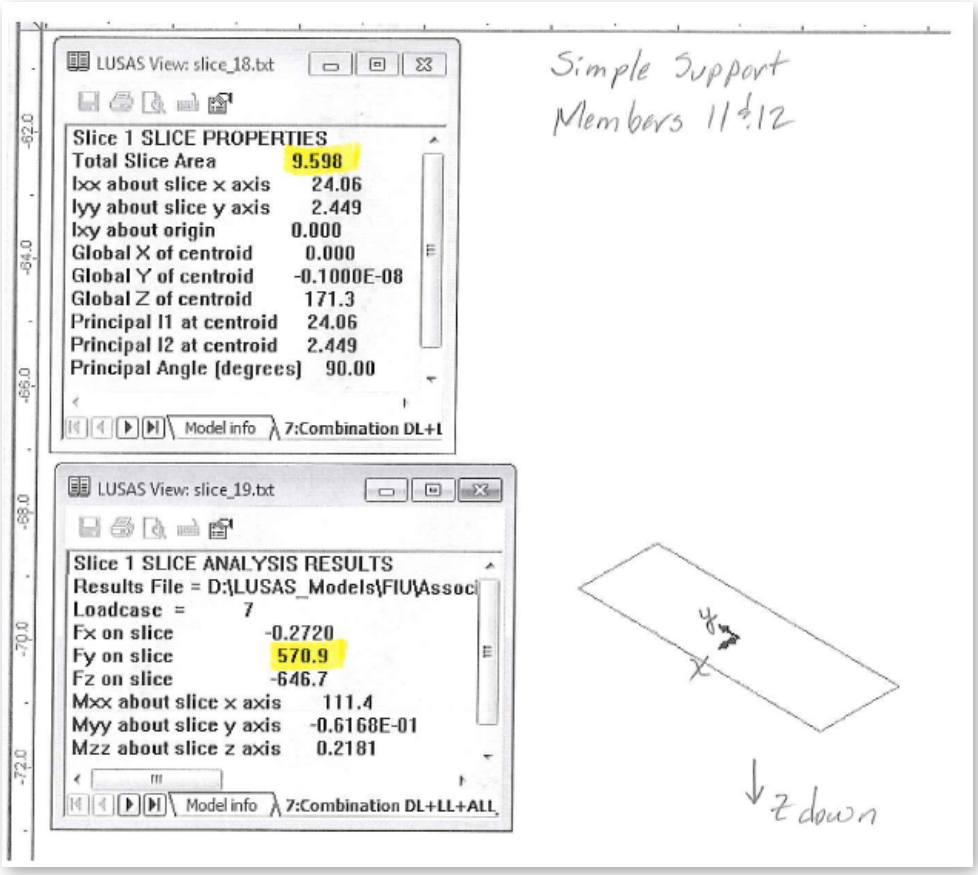
Figure 63. LUSAS screenshot of Node 11/12 interface for the Simply-Supported Model.[217]

The Design Calculation submittals also include screenshots of planar slices through the models at nodal interfaces at the Deck level, which report the internal normal and shear forces on these planes. FIGG's screenshot for the interface at Node 11/12 is shown in Figure 63. The load case producing the forces is not completely visible in the screenshots, but based on the screenshot showing longitudinal normal stress contours in Figure 61, it appears to correspond to the load case called, "DL+LL+ALL_PT."

The value, Fy, in Figure 63 is the total horizontal shear forces occurring at the slices for the given load case and combination, acting in a direction parallel to the length of the Bridge. These horizontal shear forces tend to cause sliding between the Truss Web Members and the Deck, unless the structure has adequate capacity to resist this movement. The value, Fz, is the internal force acting perpendicular (normal) to the slices, and the value, Fx, is the horizontal shear force oriented in a direction perpendicular to the length of the Bridge. All forces in these figures are reported in kips.

In the Simply-Supported condition, nearly all of the weight of the Main Span Truss must pass through the 1/2 and 11/12 interfaces. Summing the vertical forces at these two locations (1,235 and 646.7 kips) yields a reasonable total force of 1,881.7 kips, or 941 tons. This is close to the 950-ton lifting weight given by FIGG on RFC drawing Sheet B-37. However, the distribution of the force between the two interfaces is disproportionate: 66% of the vertical force is passing through Node 1/2, and the remaining 34% is passing through Node 11/12. While the Truss Web Members are not symmetrically configured, there is not enough asymmetry to produce such a large disparity in vertical force distribution. In contrast, the vertical components of DL in end diagonals in FIGG's LARSA model "Superstructure_Model_9.28.2016_MF.lar" are 761 kips (53%) and 674 kips (47%), for Members 2 and 11, respectively. The disparity in the LUSAS output conflicts with FIGG's other analysis model and is likely an indication of an error in the LUSAS model.

Further, axial force in Diagonal Members 2 and 11 would transmit most, but not all, of the weight of the Superstructure to the Substructure Piers. The orientation of the force resultants at Node 1/2 and Node 11/12 would be approximately equal to the orientations of Diagonal Members 2 and 11. And because Diagonal Members 2 and 11 are both oriented at shallow angles to the Deck, the horizontal components of force should be larger than the vertical components. However, the opposite is reflected in FIGG's LUSAS screenshots for the interface shears, again indicating an error in these models.

Finally, aside from a small amount of transverse shear in Members 1 and 12, nearly all the horizontal shear acting on these interfaces is coming from axial force in Diagonal Members 2 and 11. The magnitude of the reported horizontal shear should be related approximately to the axial force in the diagonal by trigonometry. For example, the horizontal shear force reported by FIGG in Figure 63 is 570.9 kips. Considering that Diagonal Member 11 forms a 33-degree angle with the surface of the Deck, the axial force in Diagonal Member 11 would be interpreted to be around (570.9)/cosine(33 degrees), or 681 kips. This is very different from the 1,285 and 1,253 kips axial force represented in the LARSA 4D models for DL (see Section 6.1.2). The LARSA 4D results reported in the calculation submittal also did not include any additional axial force applied through PT bars in Diagonal Member 11.

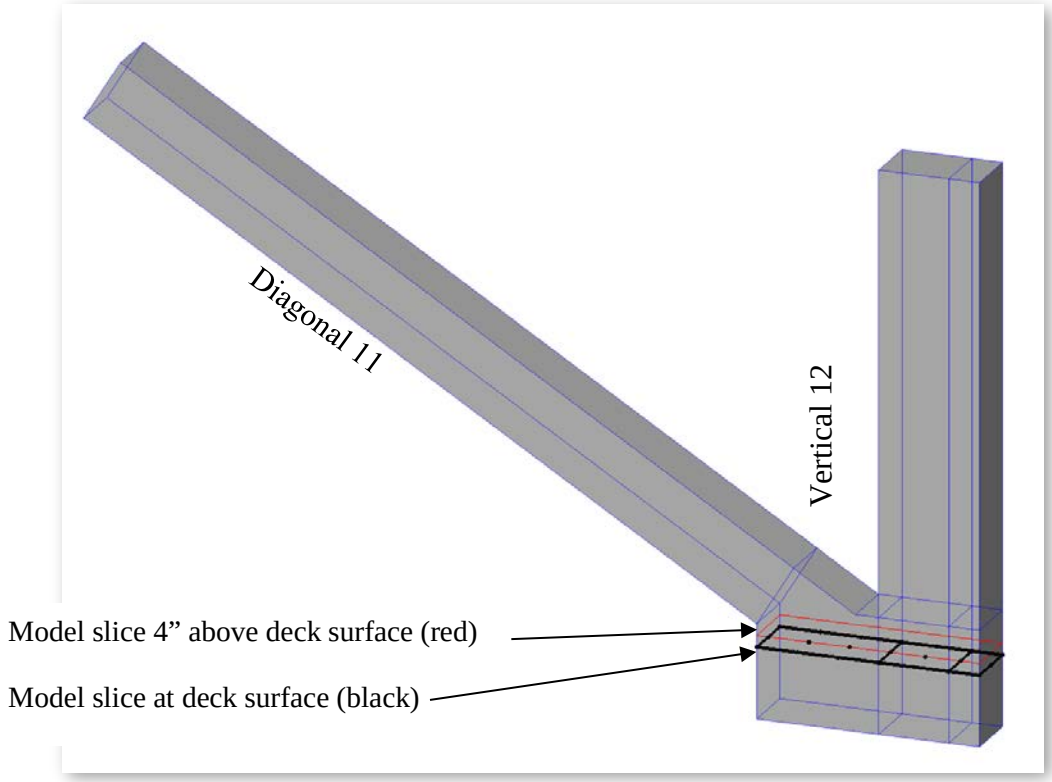
Figure 64. Example LUSAS Model Extract Showing Node 11/12 Slice Locations.

Ultimately, our review revealed a nuance of FEA that led FIGG to underestimate the nodal interface shears. Specifically, FIGG's Design Calculation submittals showed that FIGG's query of the interface shear forces was exactly at the Deck elevation. This is problematic because taking a slice through the model a small distance above the Deck surface, but still below the bottom of the incoming diagonal, yields an interface shear force significantly larger than if the slice is at the Deck, where interpolation and averaging effects of the numerical model artificially distribute the nodal forces into the Deck elements. As a result, this placement results in a calculated shear force much smaller than the actual shear force. The difference between these two model slice locations for Node 11/12 is illustrated in Figure 64.

Figure 64 includes the 10-1/2 inches of Member 12 thickness that projects north beyond the Bridge Deck, but FIGG did not include this area in its query of interface shear forces.[219] For model FIGG280209.mdl (October 5, 2016), the DL interface shears for slices at the Deck and four inches above the Deck are 635 and 852 kips, respectively (considering the same slice area as FIGG's Design Calculation submittals). Similar differences were obtained for the other models. Slicing the volume at the exact interface between the Nodes and the Deck caused FIGG to systematically underestimate the interface shears at the Truss Nodes. This underestimation of interface shears would have been discoverable by FIGG if it had compared their LUSAS results to simple hand calculations.

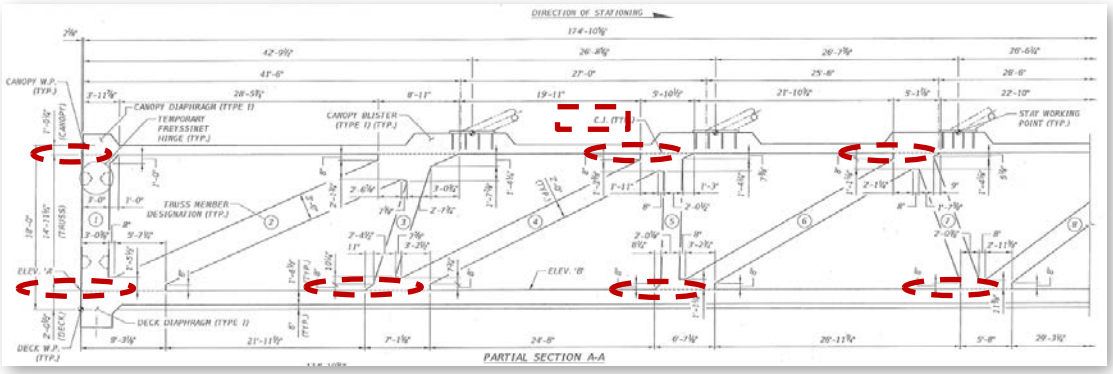
Figure 67. Example of Diagonals to Deck/Canopy construction joints. The construction joint call outs and locations are outlined in red.[253]

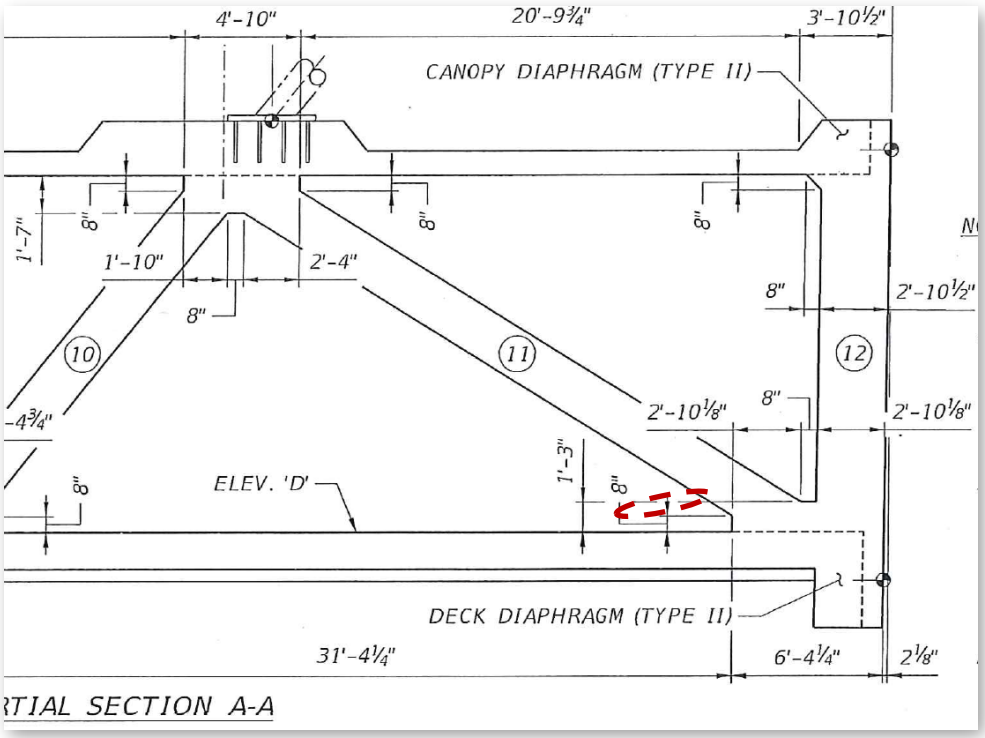
Figure 68. Shear capacity check at discontinuity at base of Member 11, as outlined in red.[254]

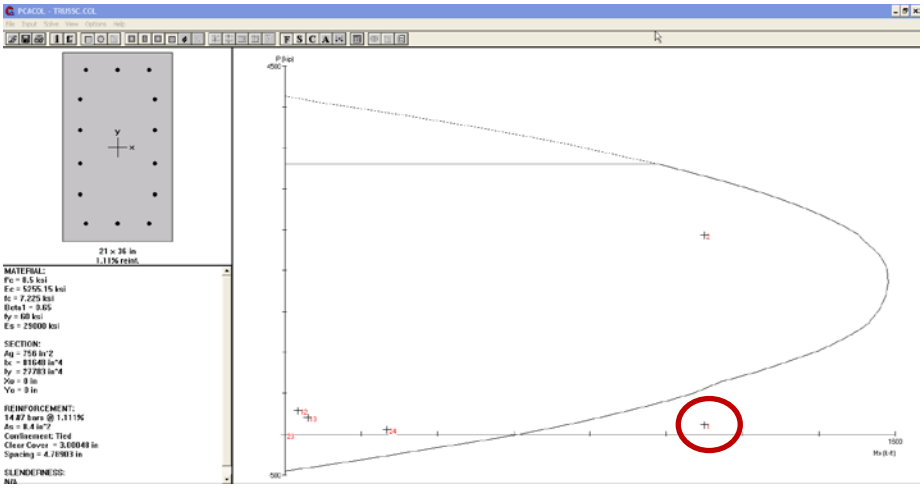
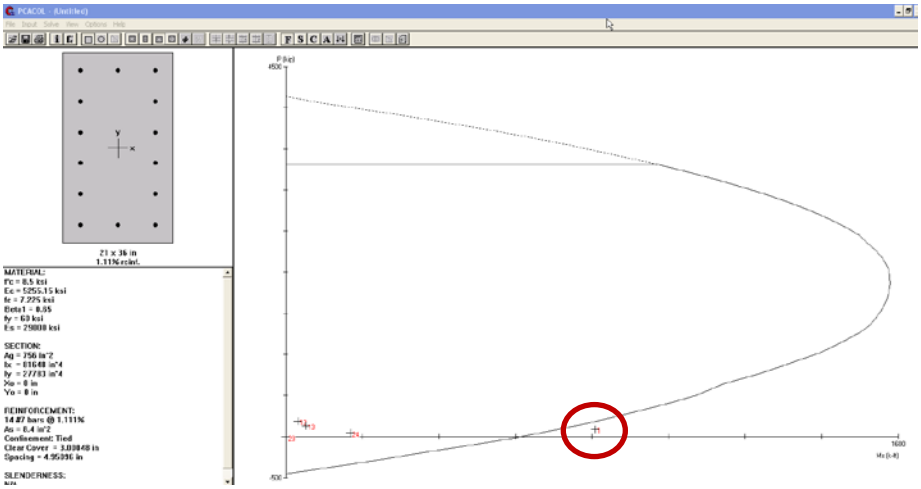
Figure 69. Louis Berger column superstructure interaction diagrams.[257] Cross marks circled in red indicate non-conforming loading conditions.

- Louis Berger's calculations appear to show that Truss Members 1 and 24 did not meet the required Design Criteria.[256] Figure 69 shows loading points outside of Louis Berger's axial force and bending moment interaction diagrams. However, the documents that Louis Berger provided did not include communications related to any discussion and/or resolution with FIGG on this issue, even though documents reviewed by us show that reinforcement in these members was increased after the 90% submittal.
