**NATIONAL TRANSPORTATION SAFETY BOARD**
Office of Research and Engineering
Washington, D.C. 20594

# Video-Based Visibility Study

**NTSB Case Number:**
**DCA20MA059**

Location:        Calabasas, California
Date:            January 26, 2020
Time:            0945 PST
Aircraft:        Sikorsky S-76B helicopter

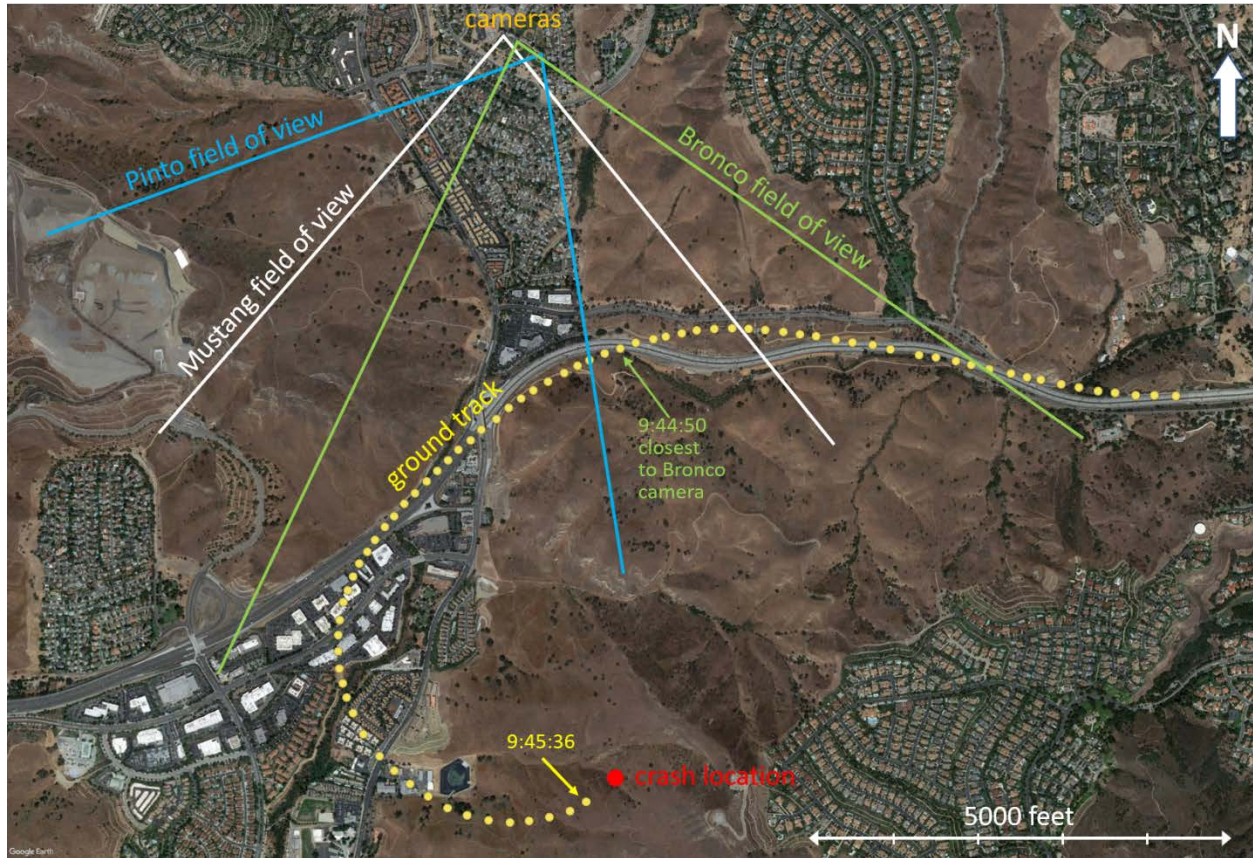
**Figure 1. Fields of View of the Three Cameras**

Figure 1 is an aerial image of the accident area with superimposed fields of view of the three cameras. The cameras were installed behind the home plates in the three baseball fields that were named Mustang, Bronco and Pinto. The ground track of the helicopter based on ADS-B data and the crash location are also shown in the figure.

Figure 1 shows that the Bronco camera provided the best coverage of the ground track. The ADS-B data provided accurate timing of the helicopter locations along the ground track. The three videos had time stamps but they were not accurate because the clocks in the video recording hardware were not set exactly. This necessitated synchronization of the videos with the ADS-B data that was not based on the time stamps in the videos. Once synchronized, analysis could concentrate on the segments in the videos where the helicopter should have been visible if within the visibility range at the time of the accident. The sound of the helicopter as recorded by the Bronco camera was used to synchronize the videos with ADS-B data, as follows.

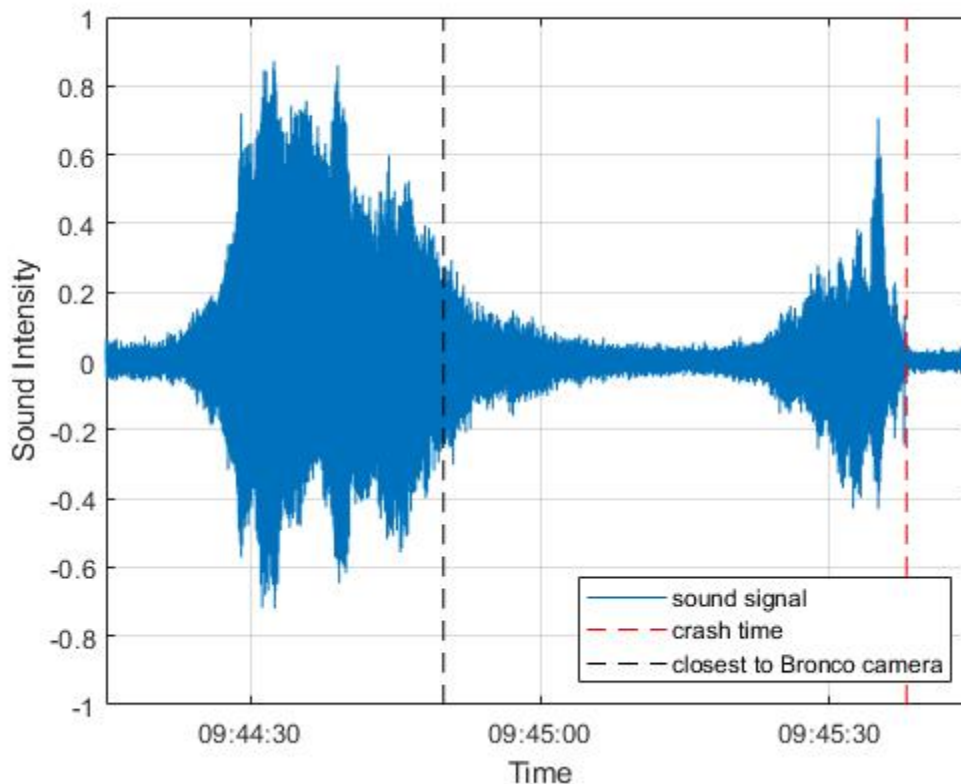
**Figure 2.  Helicopter Sound Recorded by the Bronco Camera**

The sound signal in Figure 2 posed three questions.  The first was whether both time segments of high sound intensity represented sound generated by the accident helicopter.  The second question was the timing of the helicopter's terrain impact relative to the sound signal.  The third question was whether the time history of the sound signal in Figure 2 was consistent with the ground track of the helicopter shown in Figure 1.

The sound signal in Figure 2 has two segments of high intensity separated by more than 20 seconds of low intensity. To answer the question whether both high-intensity segments are the sound of the accident helicopter, spectrum analysis similar to that shown in Figure 3 was performed along the time period shown in Figure 2. The rotor blade frequency between 100% and 107%, modified by the Doppler effect, was detected in both segments of high intensity and even in the low-intensity segment between them. The blade frequency component was not detected past the 'crash time' marked by the red broken line in Figure 2. Consequently, it was concluded that the sound corresponding to the two segments of high intensity in Figure 2 was generated by the accident helicopter.

Figure 1 shows that the last ADS-B location was at time 9:45:36. Based on the distance from that location to the crash location, it was estimated that crash occurred at about time 9:45:38. This is the time marked as 'crash time' in Figure 2. Figure 2 also shows the 'closest to Bronco camera' time. This time is about 20 seconds past the time where the first elevated intensity segment in the figure reached its highest values. It is believed that this delay is due to terrain over which sound had to propagate to reach the camera. During the 20 seconds before reaching the 'closest to Bronco camera' location, sound propagated over hilly terrain with almost no vegetation. When reaching the closest point and after that time, sound had to propagate over residential and commercial buildings. It is possible that the hilly terrain provided lower sound attenuation than the urban area, which could explain why the signal intensity was not highest at the location that was closest to the camera.

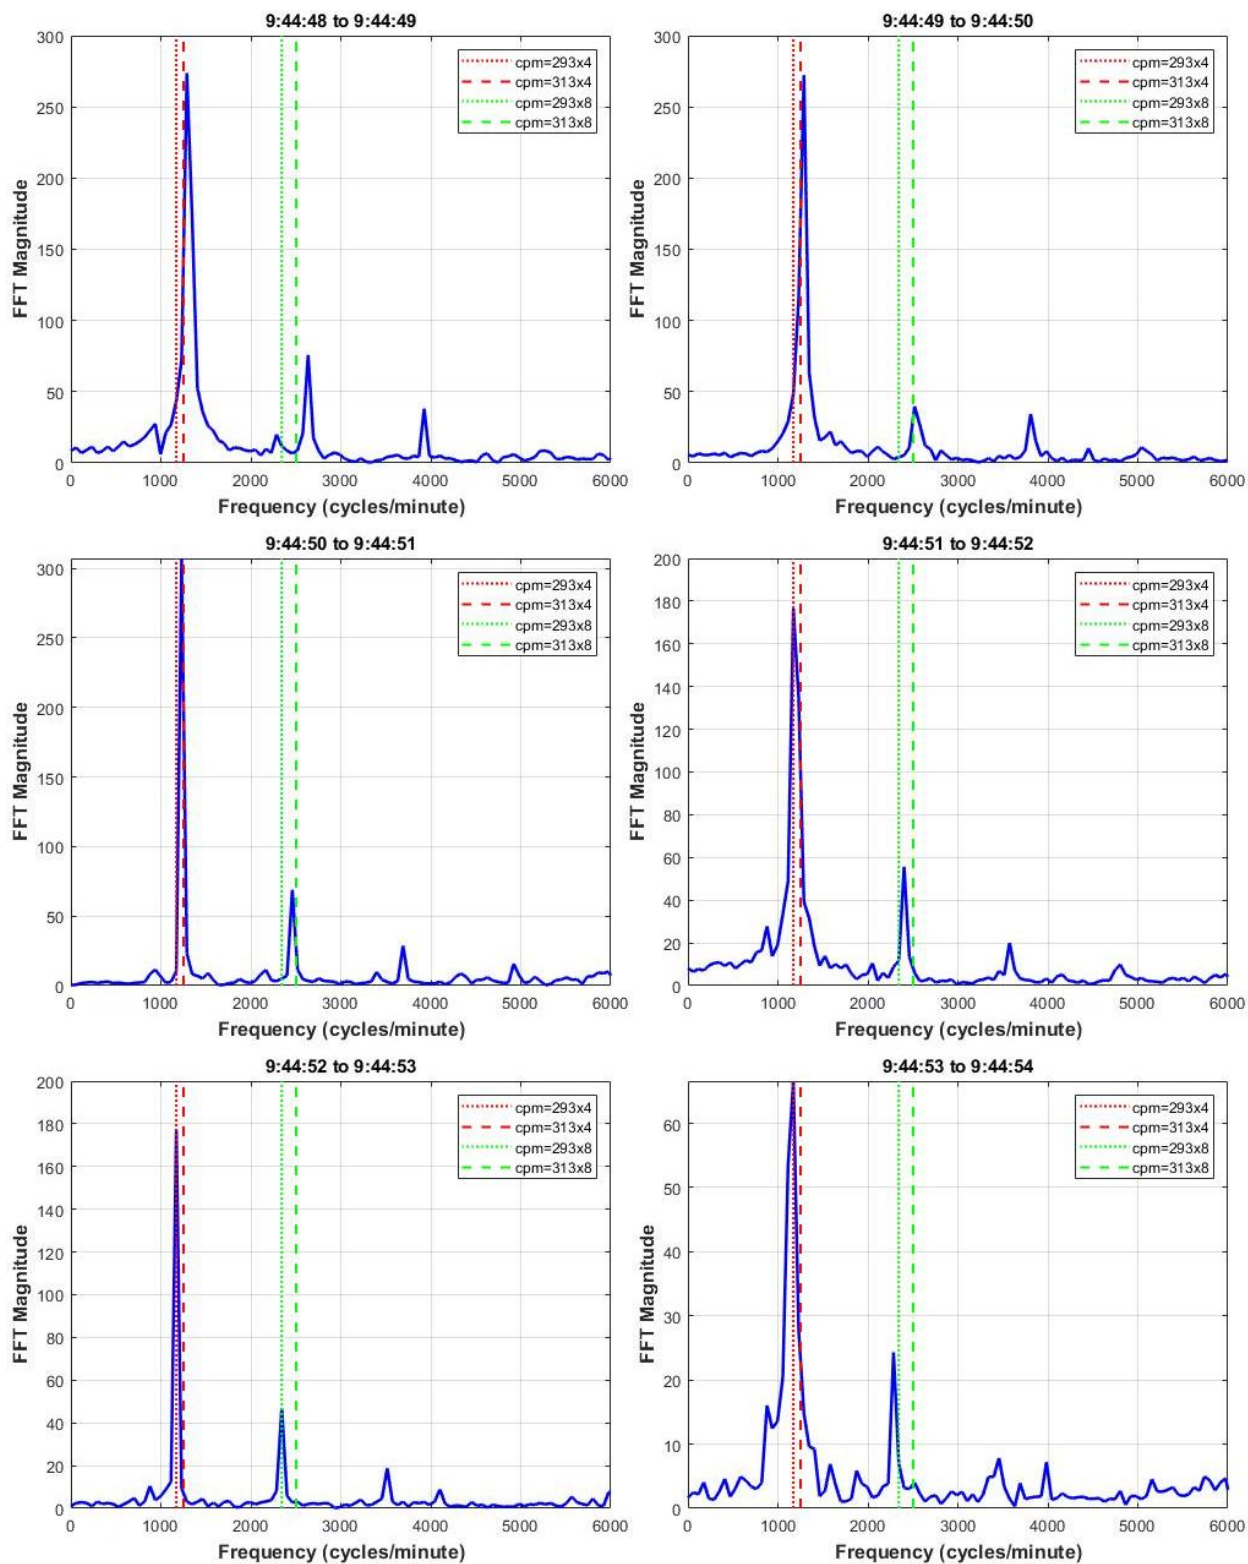
**Figure 3.  Spectrum of Helicopter Sound Recorded by the Bronco Camera**

Figure 3 shows the results of spectrum analysis of the sound signal.  It was expected that near the point of closest distance to the camera, the helicopter speed will have no component toward or away from the camera and the recorded rotor sound will not be affected by the Doppler effect.  Since the rotor speed was expected to be in the 293 rpm to 313 rpm range, and the S-76B rotor has four blades, the frequency range of interest was 293×4 cycles/minute to 313×4 cycles/minute, i.e., 1172 cycles/minute to 1252 cycles/minute.

This frequency range is marked in Figure 3, as is the frequency range corresponding to the second harmonic, i.e., 293×8 cycles/minute to 313×8 cycles/minute. Examination of Figure 3 reveals that at about time 9:44:50, the recorded rotor sound frequency was in the expected range between 100% and 107%, indicating that the ground track at that time was approximately perpendicular to the line of sight from the camera to the helicopter. This analysis made it possible to assign time 9:44:50 to the 'closest to Bronco camera' location shown in Figure 1. This time is quite accurate because Figure 3 shows that three seconds earlier or three seconds later, the recorded sound frequency was outside of the expected range where the Doppler effect is minimal.

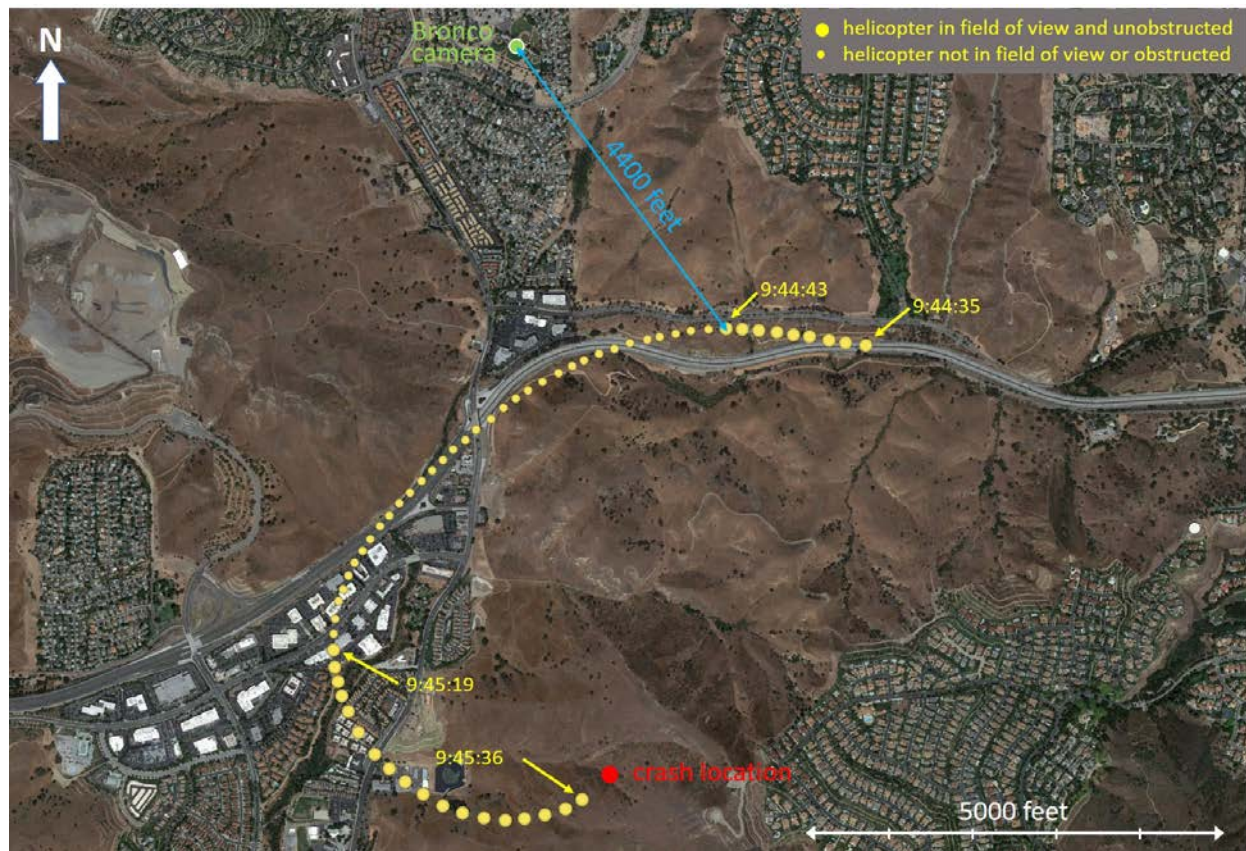
**Figure 6. Clear-Day Visibility of the Helicopter – Bronco Camera**

The helicopter image was not seen in the Bronco camera video or in the Mustang or Pinto camera videos.  To estimate visibility based on this fact, it had to be determined whether the helicopter passed locations where it would have been seen in a video recorded on a clear day.  Using the camera model and the ADS-B data, it was estimated at which points on the ground track the helicopter was within the field of view of the camera and unobstructed by terrain or trees.  Figure 6 shows an aerial image of the accident area where the points on the ground track where the helicopter would be visible

are marked by large yellow markers, and points where the helicopter would not be visible are marked by small yellow markers. The start and end times of the segments where the helicopter would be visible on a clear day are also indicated.

The blue line in Figure 6 indicates the shortest distance between a visible location and the Bronco camera. This distance was 4400 feet. The helicopter was relatively far from the camera and its 52.5 foot length would have been seen in the video frame on a clear day as indicated by the red line marked 'helicopter length.' That is the size if the longitudinal axis of the helicopter was perpendicular to the line of sight from the camera to the helicopter. When the helicopter reentered the field of view past time 9:45:19, its

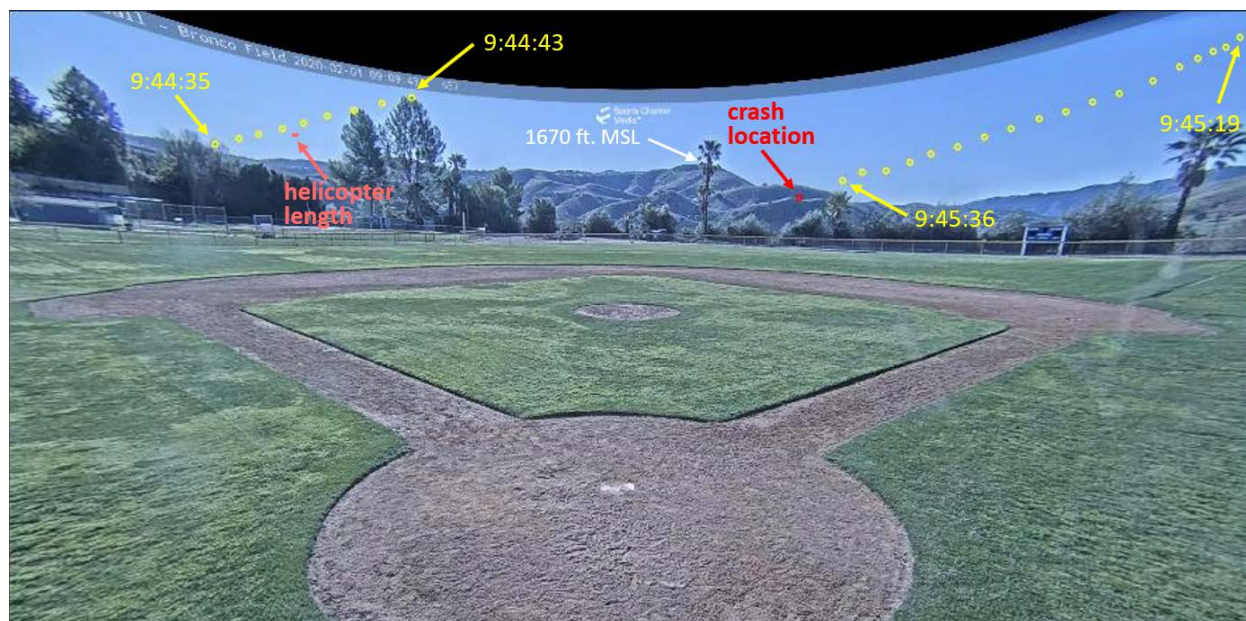
**Figure 7.  Helicopter Visibility on a Clear Day (Bronco Camera Video)**

The points shown in Figure 6 where the helicopter would have been visible are also shown in the video frame in Figure 7 at the frame locations where the helicopter image would have been located on a clear day. The black area on top of the figure is due to the barrel-distortion removal process. Since the camera was pointed south, the helicopter image would have entered the clear-day video frame from the left, as it emerged from behind trees, at time 9:44:35. Past time 9:44:43 the climbing helicopter exited the field of view through the top boundary. It reentered the field of view at time 9:45:19 as it was descending. The last ADS-B location, at time 9:45:36, is also visible and is marked in the figure.

length in the video frame would have been less than half of the marked size in Figure 7 because then it was more than twice as far from the camera.

Consequently, the estimated visibility range based on the analysis above was shorter than 4400 feet.   The analysis did not provide information on how much shorter than 4400 feet it was.   The estimated visibility was of an object that was very small compared to the 4400-foot distance from the camera.   Therefore, this analysis did not provide information on the visibility of large objects, such as the hills seen in Figure 7, that is more representative of the visibility the helicopter pilot was facing.  Visibility range to larger objects was likely to be longer than 4400 feet.   The following analysis does provide information of the visibility of larger objects.

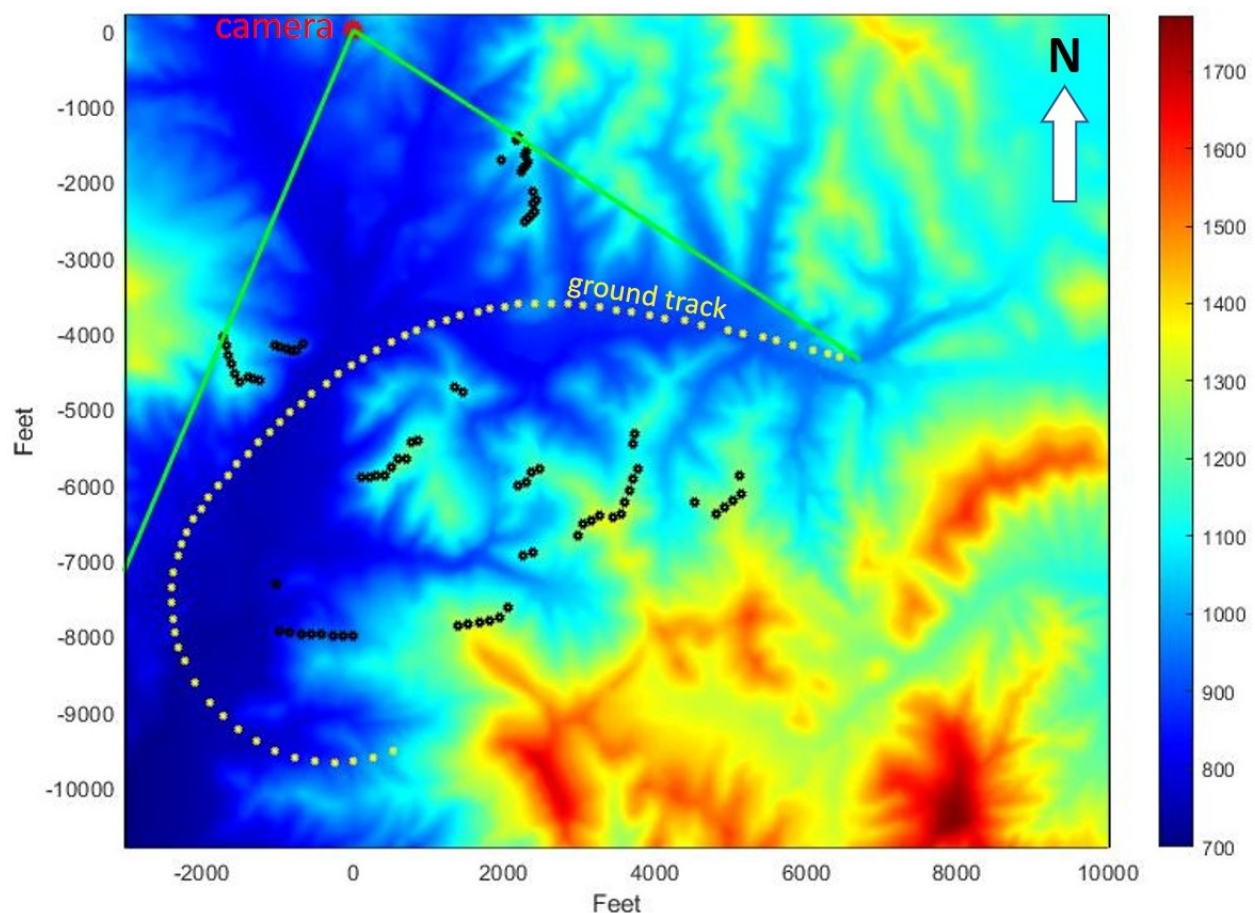
**Figure 8. Elevation Map with Marked Locations of Largest Pitch Angles from Bronco Camera to Terrain that Is Closer than 8000 feet**

Figures 8 and 9 are color-coded elevation maps of the accident area. The black markers in Figure 8 are the locations where the pitch angles from the Bronco camera to terrain were the largest when the assumed visibility range was 8000 feet. Figure 9 shows the locations where the pitch angles to terrain were the largest when the assumed visibility range was 10000 feet. The color bars on the right in the figures show the terrain MSL elevation in feet. The Bronco camera is at location (0,0) in the figures. Its elevation is 990 feet MSL.

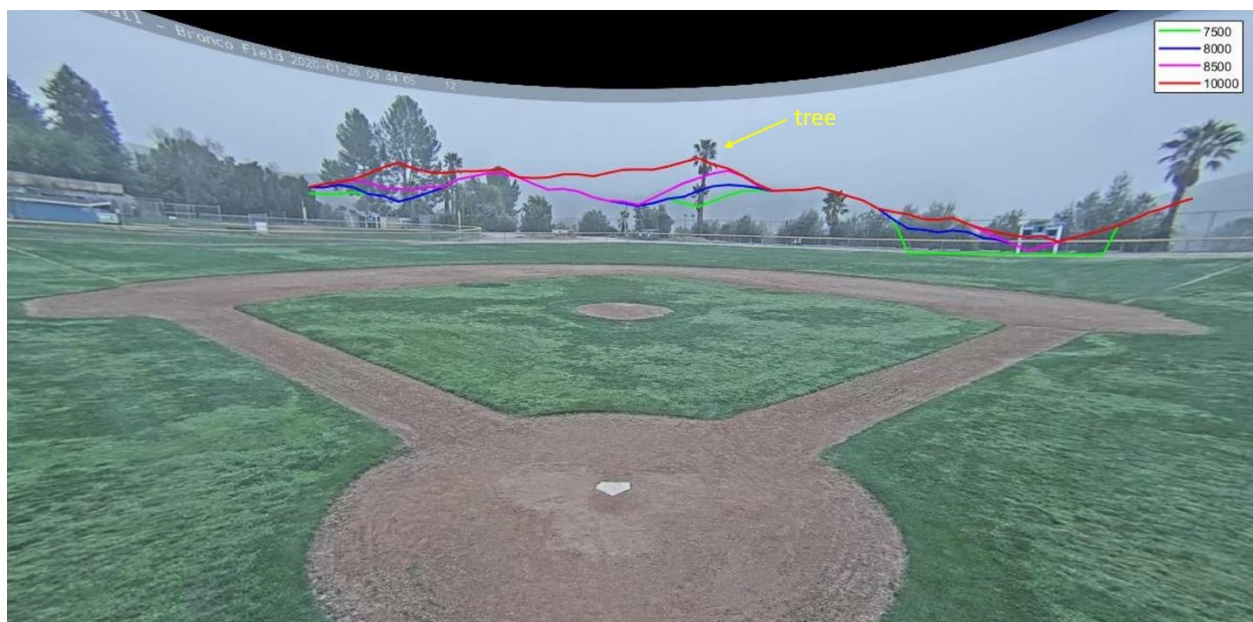
**Figure 10.  Frame from Bronco Video at Accident Time (Distortion Corrected)**

The purpose of displaying Figure 10 is to allow more accurate estimation of the terrain outline in Figure 11.  Once the curves are superimposed on the video frame, the barely-visible outline of the terrain is difficult to see.

The four curves in Figure 11 correspond to four assumed visibility ranges.  The curves are drawn so that if two curves coincide, the color shown is the one corresponding to the longer visibility range.  The actual visibility range at the accident time can be estimated based on Figure 11 if there is a curve corresponding to visibility range $R_1$ that matches the outline of terrain in the figure and a curve corresponding to visibility range $R_2$, where $R_2 > R_1$, that is higher than the terrain outline.  If the condition is met, the visibility

The tree marked in Figure 11 can be used to estimate the visibility range. Examination of Figure 11 and Figure 7 shows that visibility was less than 10000 feet because the hill behind the tree is visible in Figure 7 but not visible in Figures 10 and 11.

A more detailed examination of Figure 11 reveals that terrain details are visible at the distance of 7500 feet, the green curve, but are not visible at the distance of 8000 feet, the blue curve. Therefore, the visibility range estimate based on the Bronco camera video is 8000 feet or 1.5 miles.

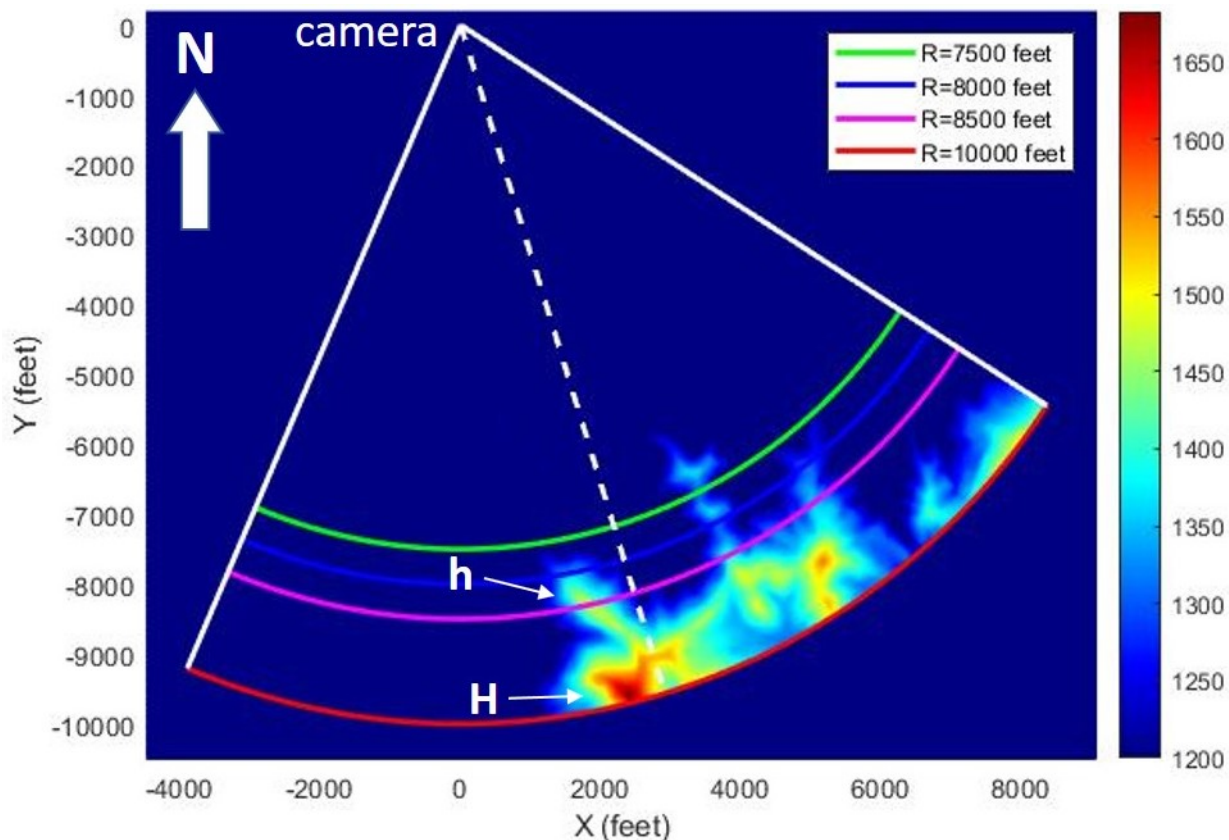
**Figure 12. Terrain Elevation in Field of View of Bronco Camera**

Figure 12 is a map of the terrain elevation in the field of view of the Bronco camera. The figure shows a subset of the information in Figures 8 and 9. The shown area is limited to be within the field of view of the camera and at a distance of 10000 feet or less from the camera. The elevation scale starts at 1200 feet MSL. The broken white line marks the yaw orientation of the camera. Terrain along that line maps onto a vertical line passing through the horizontal center of video frames such as the one in Figure 11.

The four arcs in the figure, at 7500 feet, 8000 feet, 8500 feet and 10000 feet from the Bronco camera, correspond to the four terrain contour lines in Figure 11. Since the

Y axis in Figure 12 is oriented along the north direction and the Bronco camera is oriented approximately in the south direction, locations right of the broken white line in Figure 12 correspond to locations that are left of the horizontal center of Figures 7, 10 and 11. The hilltop at 1670 feet MSL marked in Figure 7 is marked as H in Figure 12. Location h marked in the figure is a ridgeline, at about 1450 feet MSL, that is part of an area of higher elevation that starts at about 7700 feet from the camera and is visible in Figure 10 and in Figure 11.

The key question is why the terrain near ridgeline h was visible in the Bronco camera video and hilltop H was not visible. The three possibilities are:

1. Visibility was limited by mist caused by uniformly-distributed high relative humidity. Ridgeline h, part of the elevated area that starts at about 7700 feet from the camera, was at the limit of the visibility range, as can be appreciated in Figures 10 and 11. The additional distance from there to hilltop H pushed hilltop H beyond the visibility range.

2. Visibility was limited by mist caused by non-uniformly-distributed high relative humidity. It is possible that the relative humidity beyond 8000 feet was higher than what it was up to 8000 feet, thus limiting the visibility range to approximately 8000 feet.

3. Mist was caused by uniformly-distributed relative humidity but the cloud base was about 1450 feet MSL in the area near locations h and H. This placed the area near ridgeline h below the cloud base and hilltop H above the cloud base. Since the altitude of the helicopter based on ADS-B data was higher than 1450 feet, it could have been flying above the cloud base. If this was the case, the visibility range that the pilot was facing was probably less than the 1.5 miles estimated above.

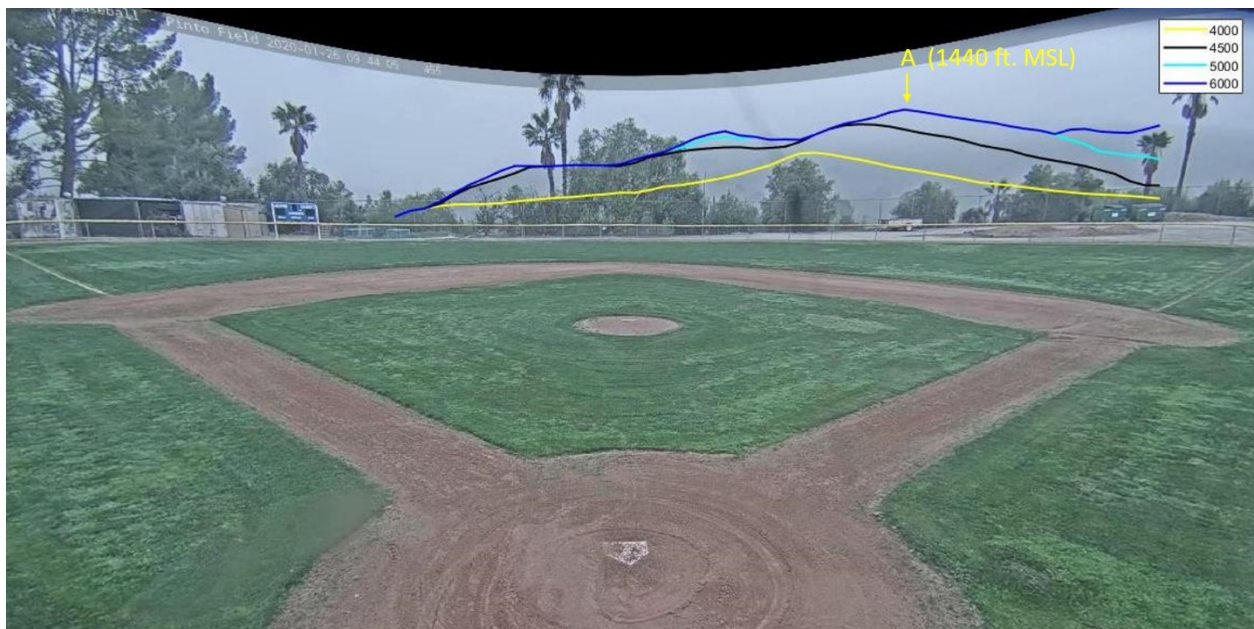
**Figure 15.  Frame from Pinto Video at Accident Time (Distortion Corrected)**

Figure 15 shows a frame from the Pinto video that was recorded at the time of the accident and after the barrel distortion was corrected. Figure 16 shows that video frame with superimposed terrain outline curves computed for visibility ranges of 4000 feet, 4500 feet, 5000 feet and 6000 feet.

Examination of Figures 13, 15 and 16 reveals that at the frame location marked as A in Figure 13 and in Figure 16, the terrain outline curve corresponding to assumed visibility range of 4500 feet matches the terrain outline but the curve corresponding to visibility range of 5000 feet does not. Therefore, the visibility range estimate based on the Pinto camera video is 5000 feet or one mile. Note that frame location A marked in Figure 13 and in Figure 16 is west of the ground track shown in Figure 1.

The Pinto video continued for about 17 minutes after the helicopter crashed. During this time, there was a period when the visibility was slightly worse than in Figure 15 and a period when the visibility was slightly better than in Figure 15. These variations did not change the 5000 feet or one-mile visibility range estimate. However, these variations could be an indication that the cloud base was about at the elevation of hilltop A that is marked in Figure 13, i.e, 1440 feet. The observed visibility range variations could be due to clouds with slightly different bases moving between the camera and hilltop A.
