NATIONAL TRANSPORTATION SAFETY BOARD
Vehicle Recorder Division
Washington, DC 20594

Onboard Image Recorder

Specialist's Factual Report
By Sean Payne

Location: Watkins, Colorado
Date: May 31, 2014
Aircraft: Cessna 150, N6275G
Operator: Private
NTSB Number: CEN14FA265

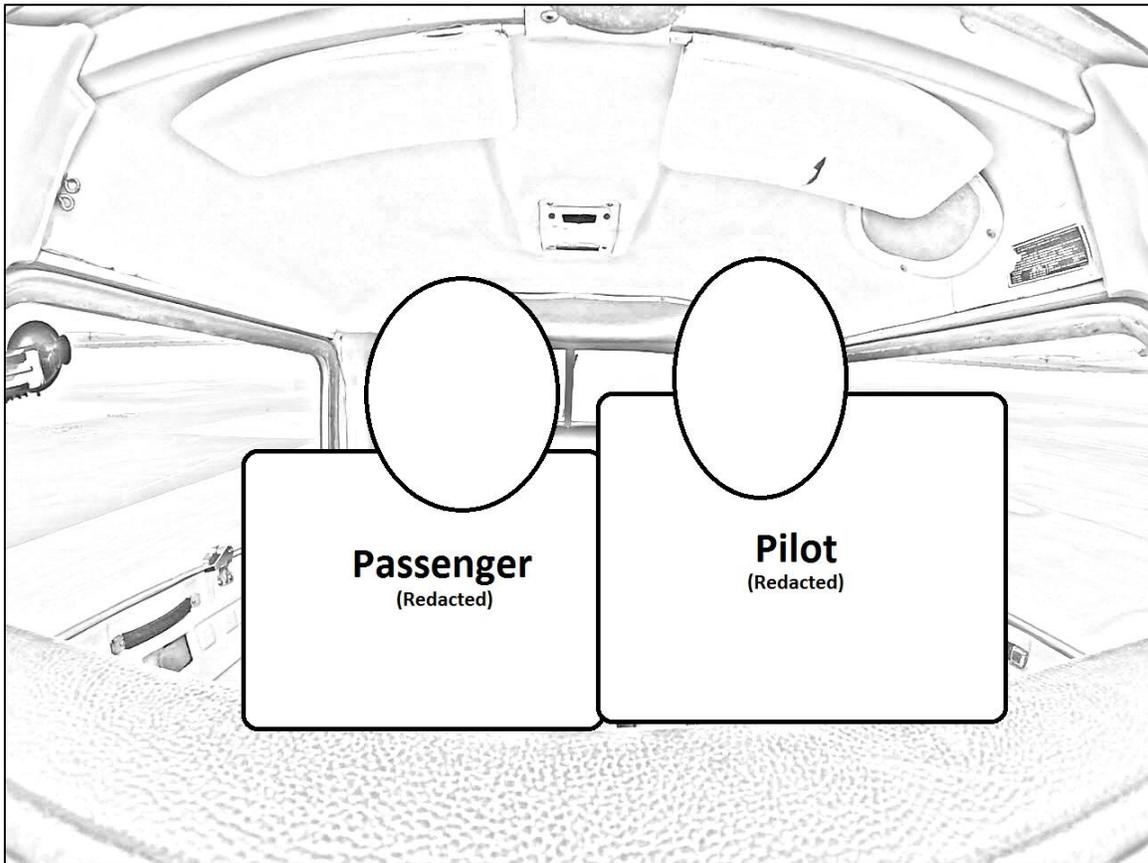
Figure 1: A digital illustration of the field of view of rearward facing image recorder.

The majority of the files were delivered in an MP4⁶ format of 1280 x 960 resolution at 47 frames per second with a 128kbps⁷ audio track that captured engine and cockpit noise in stereo. The GoPro, which was mounted to the instrument panel area in front of the pilot, was facing toward the rear of the aircraft and captured the front seat occupants as well as a view out of the left and right windows and portions of the rear window. Figure 1 shows the field of view of the rearward facing GoPro camera for most of the recording.
