NATIONAL TRANSPORTATION SAFETY BOARD

Survival Factors Group Chairman's Factual Report

CEN15MA290

Operator: Air Methods Corporation
Location: Frisco, Colorado
Date: July 3, 2015
Time: 1339 mountain daylight time
Aircraft: Airbus Helicopters AS350 B3e [N390LG]

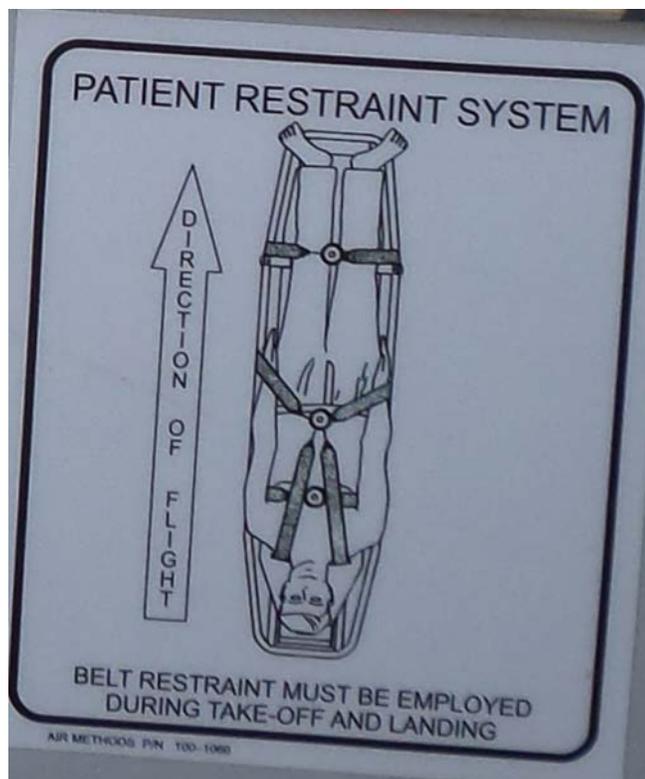
Figure 4- A placard of the litter restraint configuration.

² The label shows a four-point shoulder harness and two lap belts however the litter had a four-point shoulder harness and three lap belts.

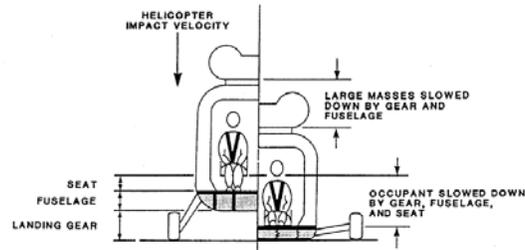
Figure 5- Potential energy management system as depicted in Coltman (1994).

The review found that vertical impacts on hard surfaces resulted in the most severe impacts because there was no energy absorption by the non-deforming ground. The authors further stressed that this vertical impact condition necessitates energy absorption in the landing gear, fuselage, and the seats such as shown in the diagram in figure 5. Survivability envelopes based on longitudinal and vertical impact velocities were also presented and are shown in figure

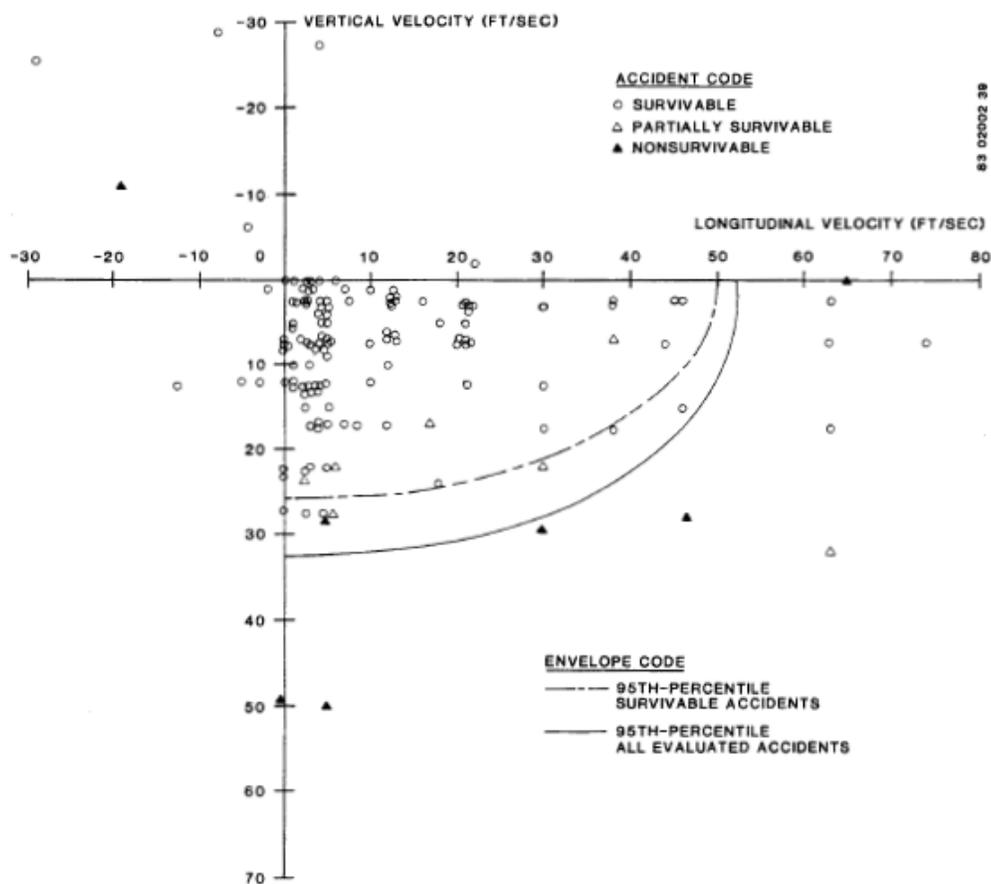
Figure 6- Survivability based on longitudinal and vertical impact velocity depicted in Coltman (1994).

6. (The review found that lateral impact velocity did not have as large an effect on survivability as the longitudinal and vertical velocities.)

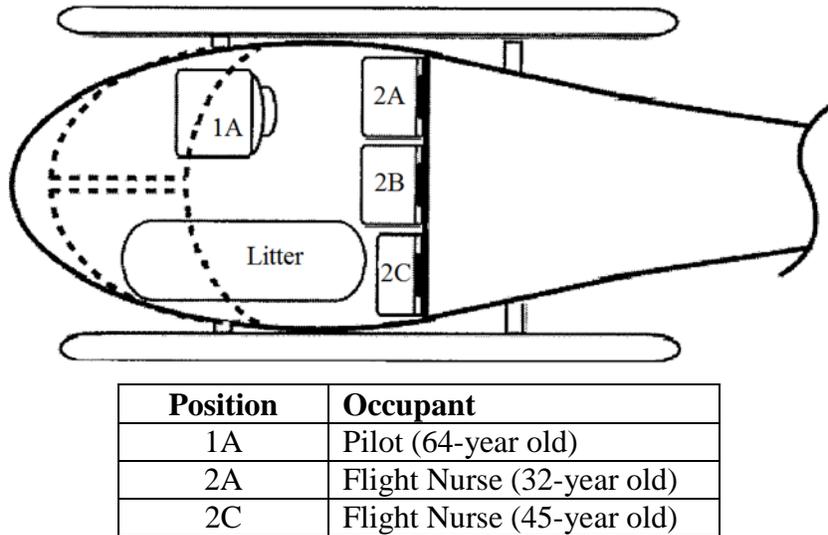
Figure 9- This seating chart shows occupant position and age.

According to an interview with the flight nurse, the pilot was seated in the pilot seat and the flight nurses were seated on the right and left most sides aft of the pilot seat (figure 9).
