PRELIMINARY REPORT

Delray Beach, Florida

HWY19FH008

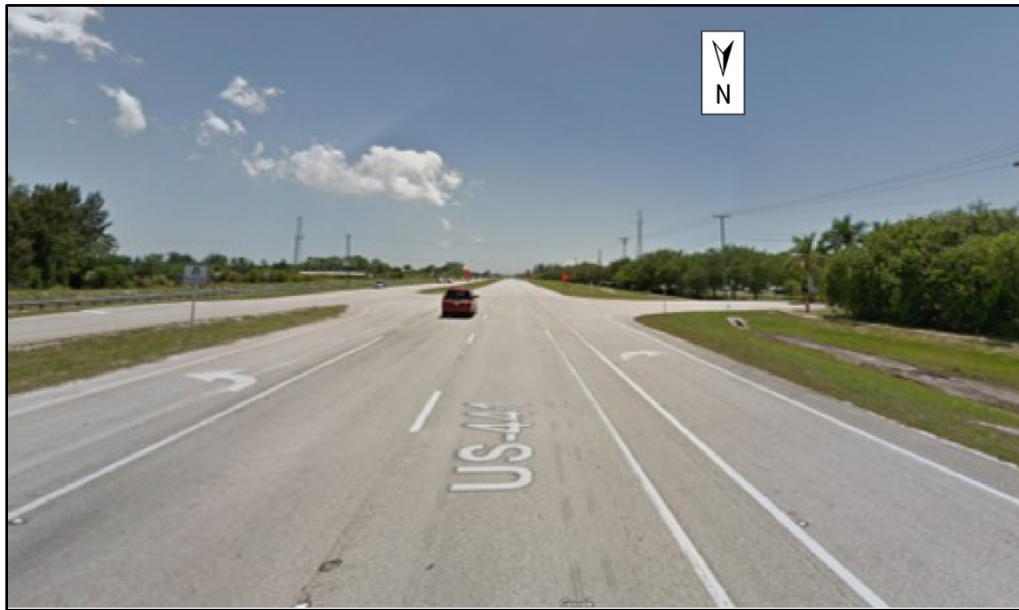
Figure 1. Southbound view of crash intersection. Private driveway into agricultural facility is visible on right side of image. (Source: Google Maps)

As the Tesla approached the private driveway, the combination vehicle pulled from the driveway and traveled east across the southbound lanes of US 441. The truck driver was trying to cross the highway's southbound lanes and turn left into the northbound lanes. According to surveillance video in the area and forward-facing video from the Tesla, the combination vehicle slowed as it crossed the southbound lanes, blocking the Tesla's path.
